# THE ALDE & ORE ASSOCIATION

## ALDE AND ORE ESTUARY ASSESSORS REPORT

| <b>NAME:</b><br><br><b>Nicholas Russell</b><br><b>Christopher Day</b> | <b>DATE OF INSPECTION:</b><br><br><b>10<sup>th</sup> April 2026</b> |
| <b>FLOOD CELL:</b><br><br>FC1S | <b>AREA OF ASSESSMENT:</b><br><br>Hollesley pumping station to Butley Ferry |

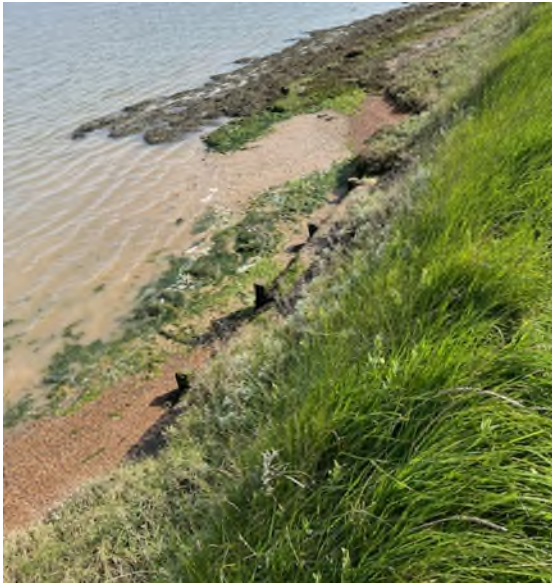
**Above from May 2024**

1. The river wall continues to be undermined at grid reference 52°04'04.0"N 1°29'47.8"E between Dove Point and the entrance to the Butley. See pictures below that show the increased erosion of the wall by the river between May 2024 and May 2025. The erosion between May 2025 and April 2026 has slowed, but nevertheless continues.

Note in the 2024 picture the wood posts and barrier are holding back the wall from being undermined by the river. Whilst in the 2025 picture 2, the river has started to breakdown the wall armour behind the posts.

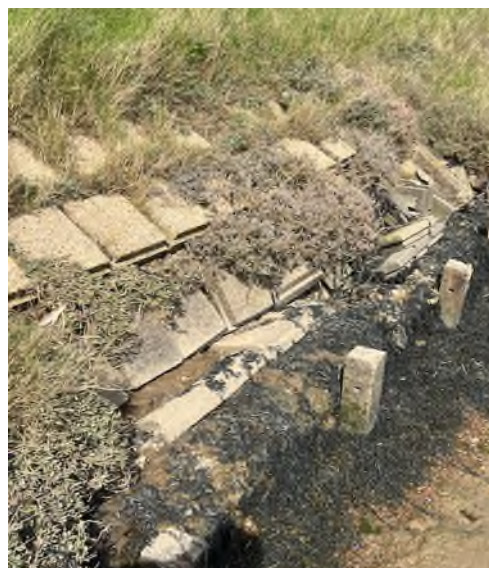
**The picture opposite is from April 2026 and is in the same location as the two photos above. Note how the water at high tide continues to undermine the wall armour.**

- Generally good condition other than the two points noted above. Further repairs to this area should be made in the next couple of years to stop the wall from being further undermined.

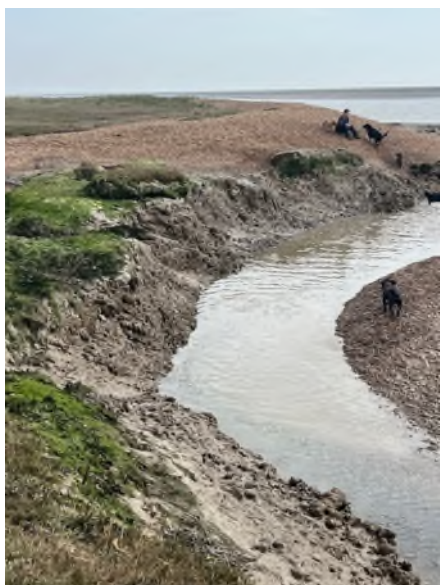
**Pic 1**

- At the location of grid reference 52°04.856'N, 1°46.293'E just before the 2<sup>nd</sup> WW look out post and river bank reinforcement, where the Barthorp's creek from Hollesley pumping station runs into the main river, the river wall defences have started to crumble into the creek. However, this is no worse than when inspected in 2025. See Pic 1 and 2 below.

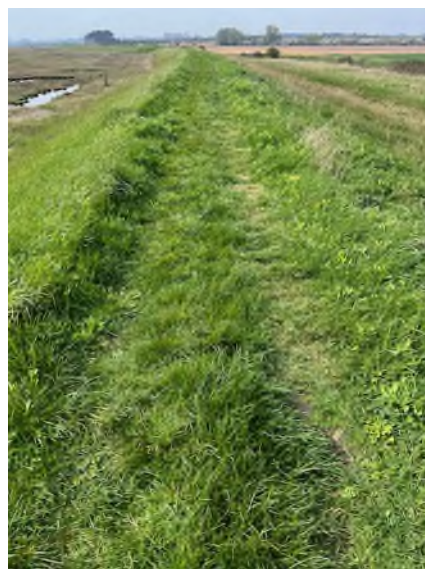
**Pic 3**

- Top showing no signs of the cracking down the middle that was evident in 2025. See photo 3 below.
- Banks all continue to have good vegetation.
- Between Butley entrance and Boyton dock at grid reference 52°04.251'N, 1°29.745'E, The cracking along the top of the wall is still there albeit difficult to see. No worse than 2025; see pics 4 and 5 below

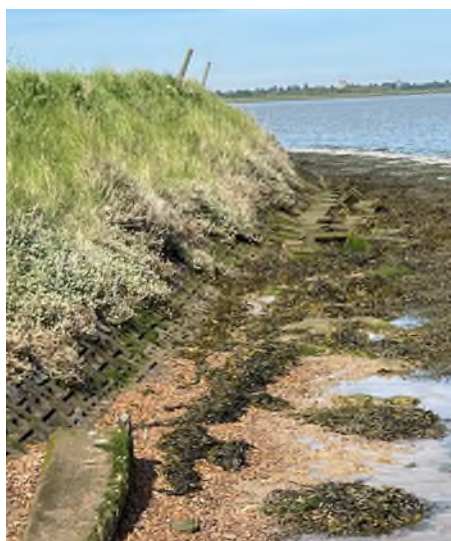
**Pic 6 May 2024**

- At grid reference 52°03.920'N, 1°29.758'E the river wall defences from the corner of Dove Point to half way along to the entrance to the Butley River continue to show extensive signs of wear, where the river wall reinforcement has and is falling onto the edge of the river. However, from the photos taken in May 2024 (Pic 6) and again in May 2025 (Pic 7) there has not been very much further deterioration over the last year. See Pics 8 and 9.

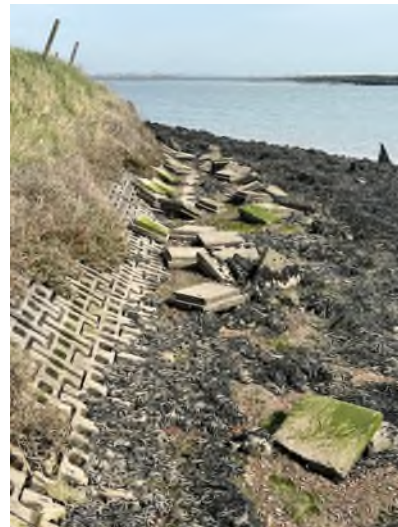
**Pic 8 April 2026 – No change**

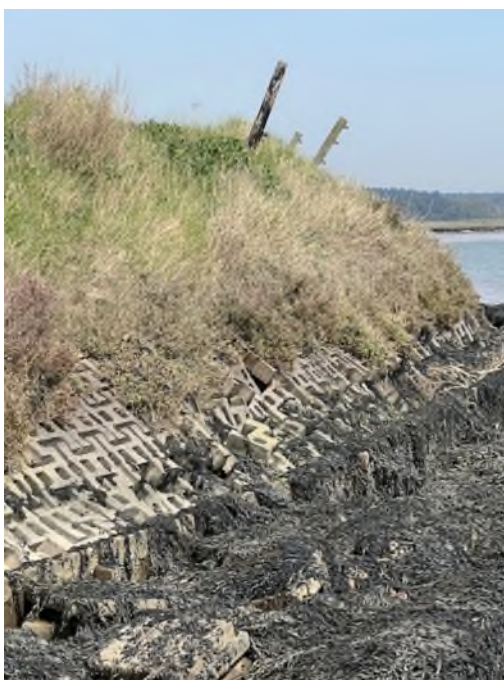
**Pic 9 - High water continues to damage the armour on the corner opposite Dove Point**

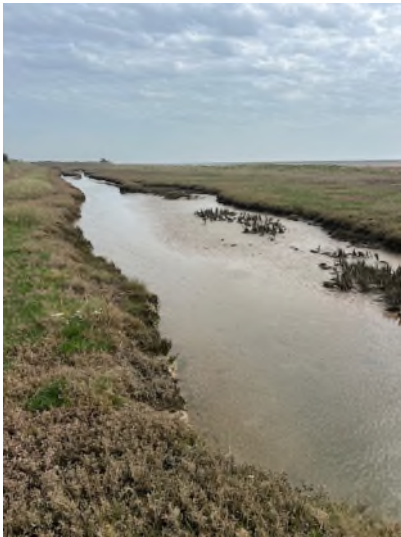
**Pic 10**

- The Simpson Saltings all looked to be in good condition with plenty of healthy marsh between the river and the river wall – See pic 10 and grid refence below.
- The creek that runs behind the 2<sup>nd</sup> WW infantry Pillbox was running well with plenty of healthy marsh between the river and the creek and the creek and the river wall. Sec Pic 11 and 12 below.
- The saltings running along the Butley river and out to the entrance of the Butley river between the river and the wall where in good condition.

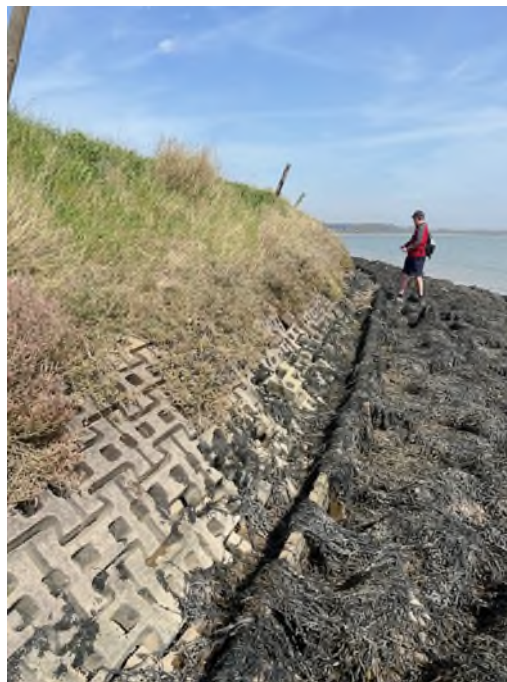
**Pic 13**

- Low. Little evidence other than between Dove Point and the entrance to the Butley where the saltings have completely eroded away and thus the high water is up against the armour . See pic 13 below.
