# THE ALDE & ORE ASSOCIATION

## ALDE AND ORE ESTUARY ASSESSORS REPORT

| <b>NAME:</b><br><br>Roger Baxter<br>Jonathan Evans | <b>DATE OF INSPECTION:</b><br><br>April 2026 |
| <b>FLOOD CELL:</b><br><br>FC2 | <b>AREA OF ASSESSMENT:</b><br><br>Butley Mills |

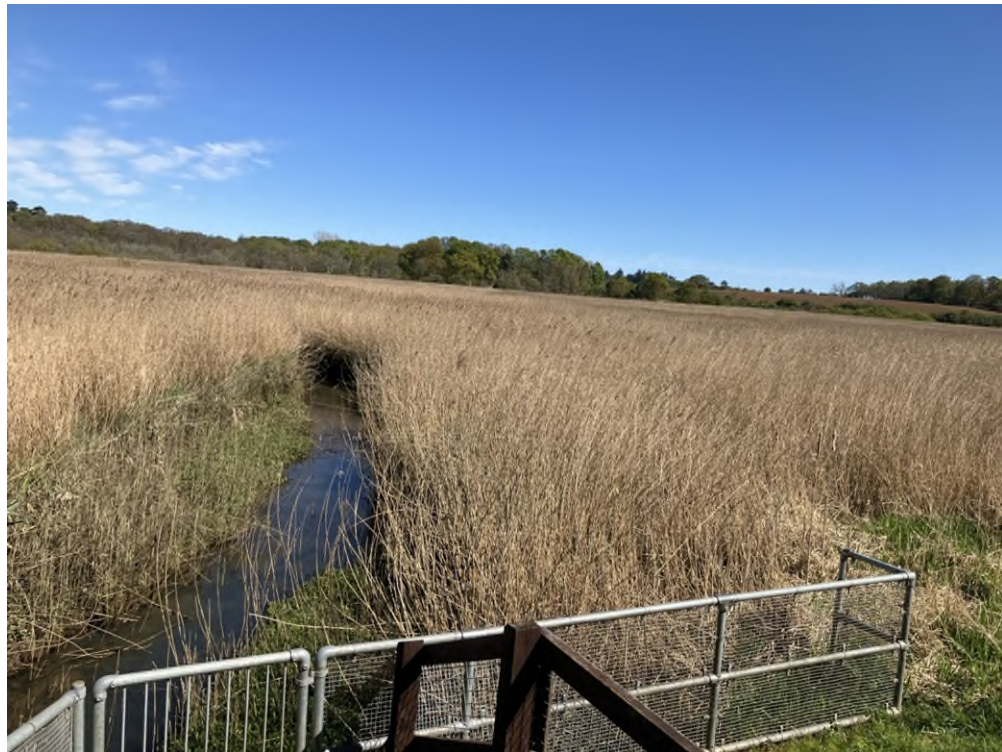
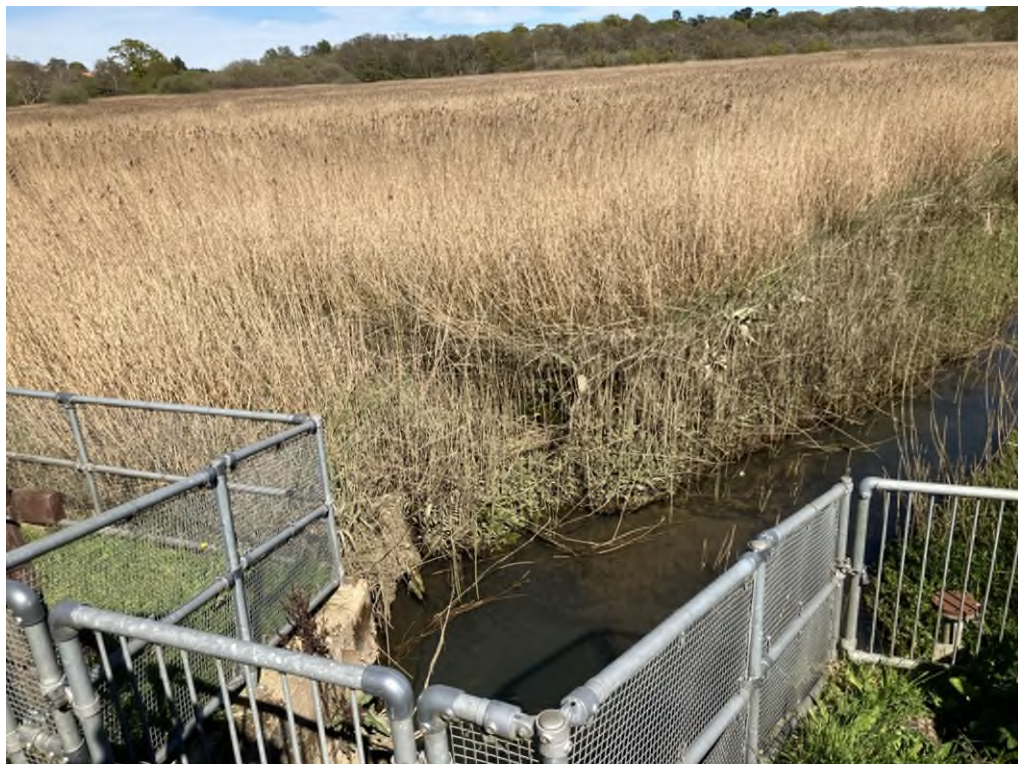
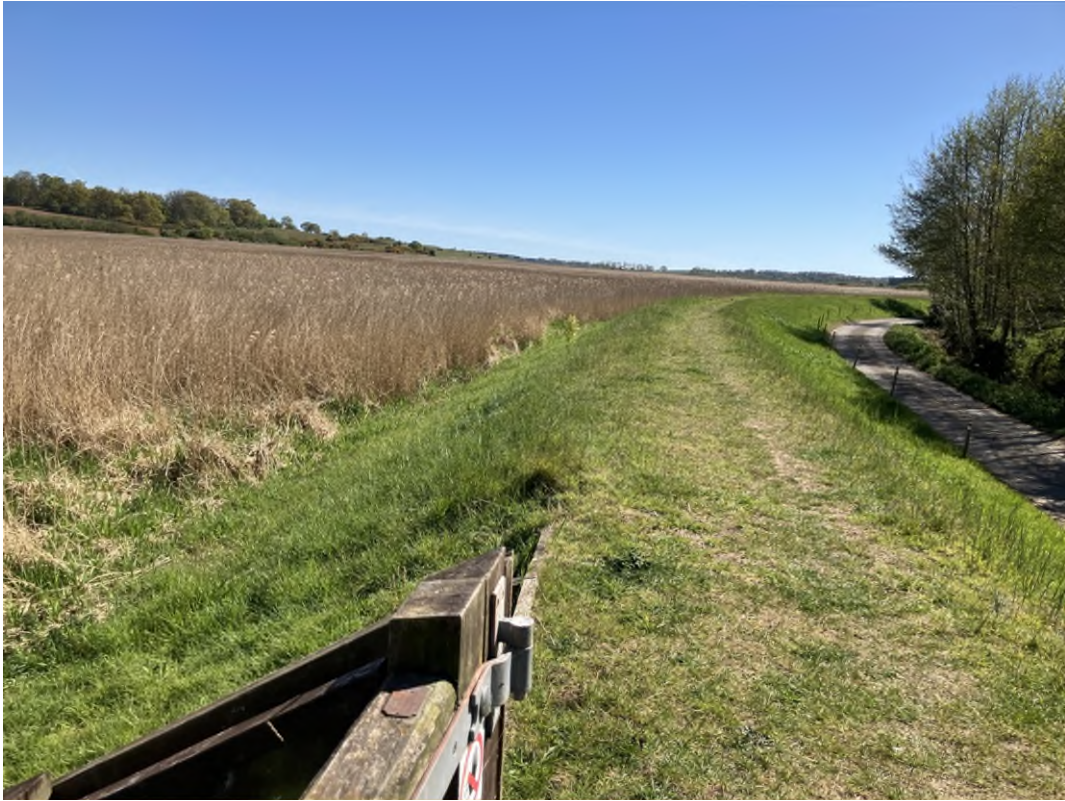
Upstream part of River Butley with wide, flat saltings populated by dense reed beds. River Wall is high and wide with a mechanically controllable sluice to allow drainage (under the road) from the mill pond. Grass is thick and short with a footpath on top. The steps from the road to the sluice controls/wall top have recently been replaced.
