# THE ALDE & ORE ASSOCIATION

## ALDE AND ORE ESTUARY ASSESSORS REPORT

| <b>NAME:</b><br><br>Frances Barnwell | <b>DATE OF INSPECTION:</b><br><br>29 April 2026 |
| <b>FLOOD CELL:</b><br><br>FC4-2 | <b>AREA OF ASSESSMENT:</b><br><br>Chantry Marshes to Orford Quay |

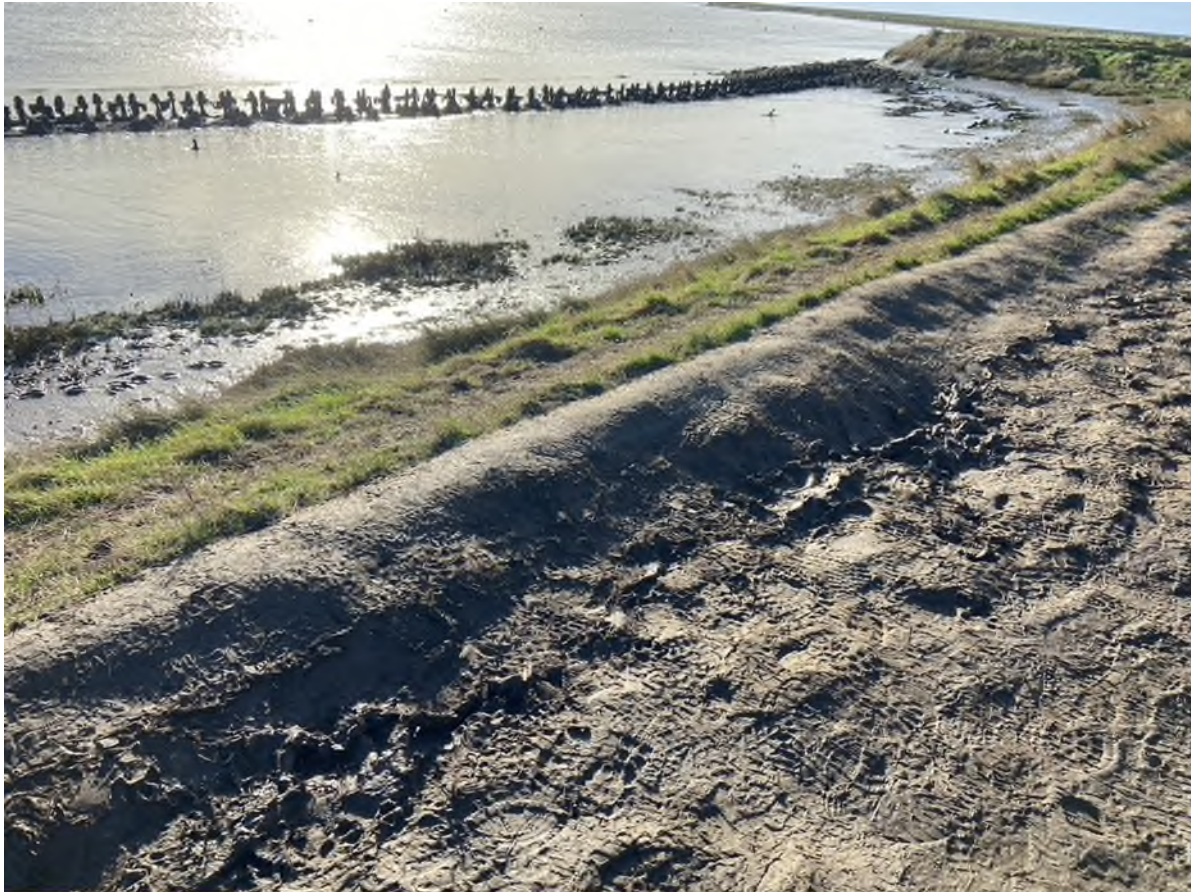
The photo below shows how a rim of mud has accumulated.

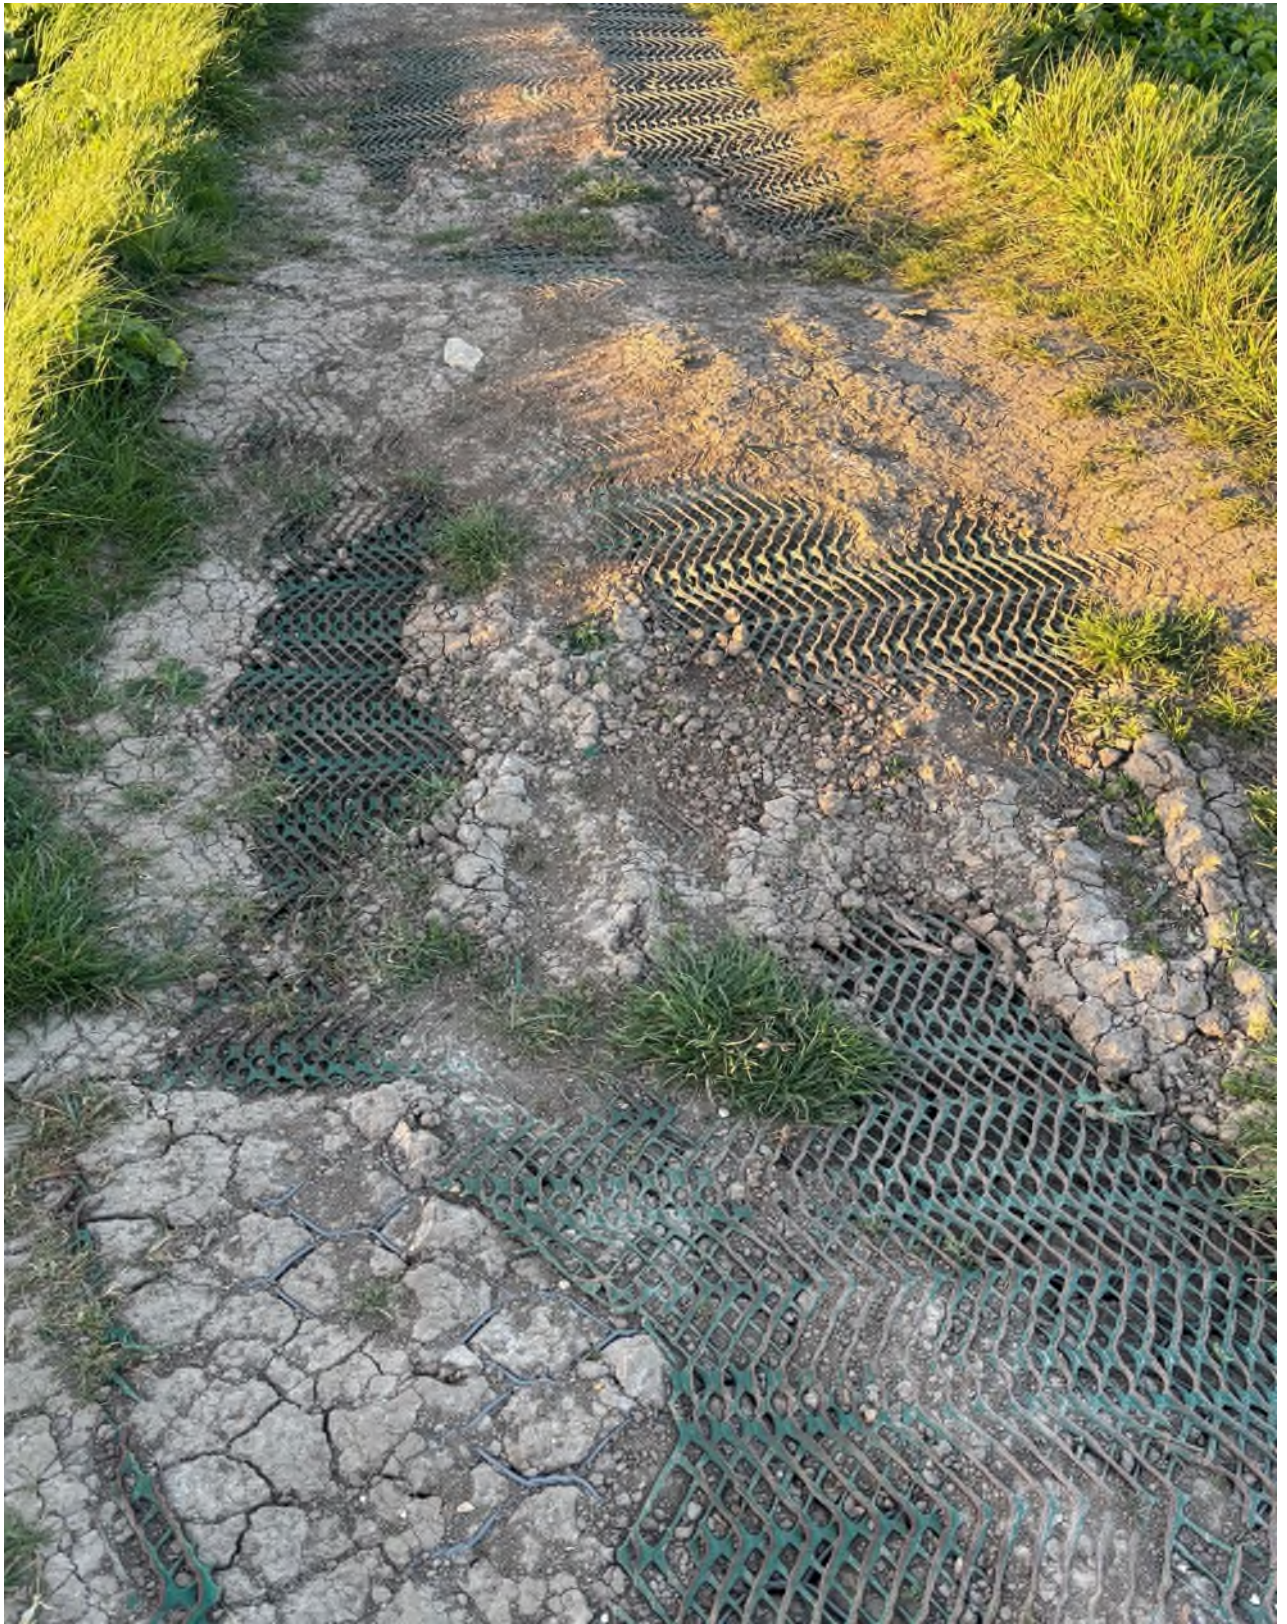
The section of the wall covered by webbing is continuing to deteriorate and the webbing to break up posing trip hazard, especially in wet weather. Extensive muddy sections suggest that areas of surface are likely to be lost in wet weather.

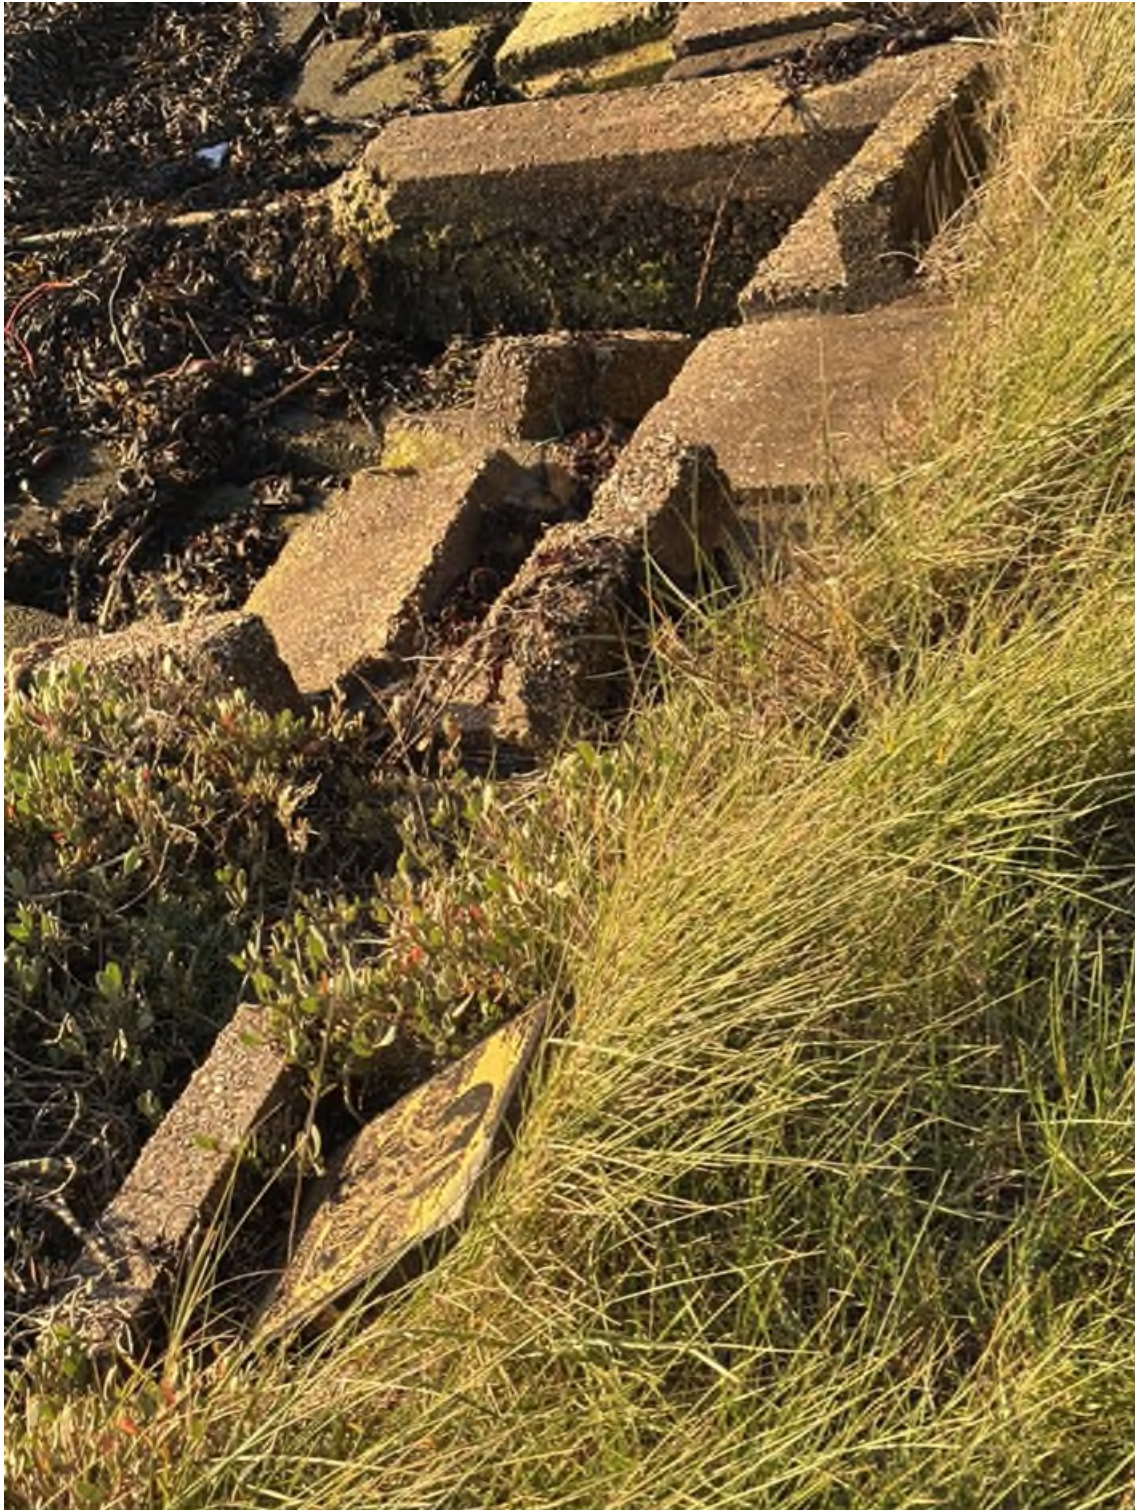
There is evidence of slippage on the sides. The blockwork is damaged in placed but does not appear different from last year.

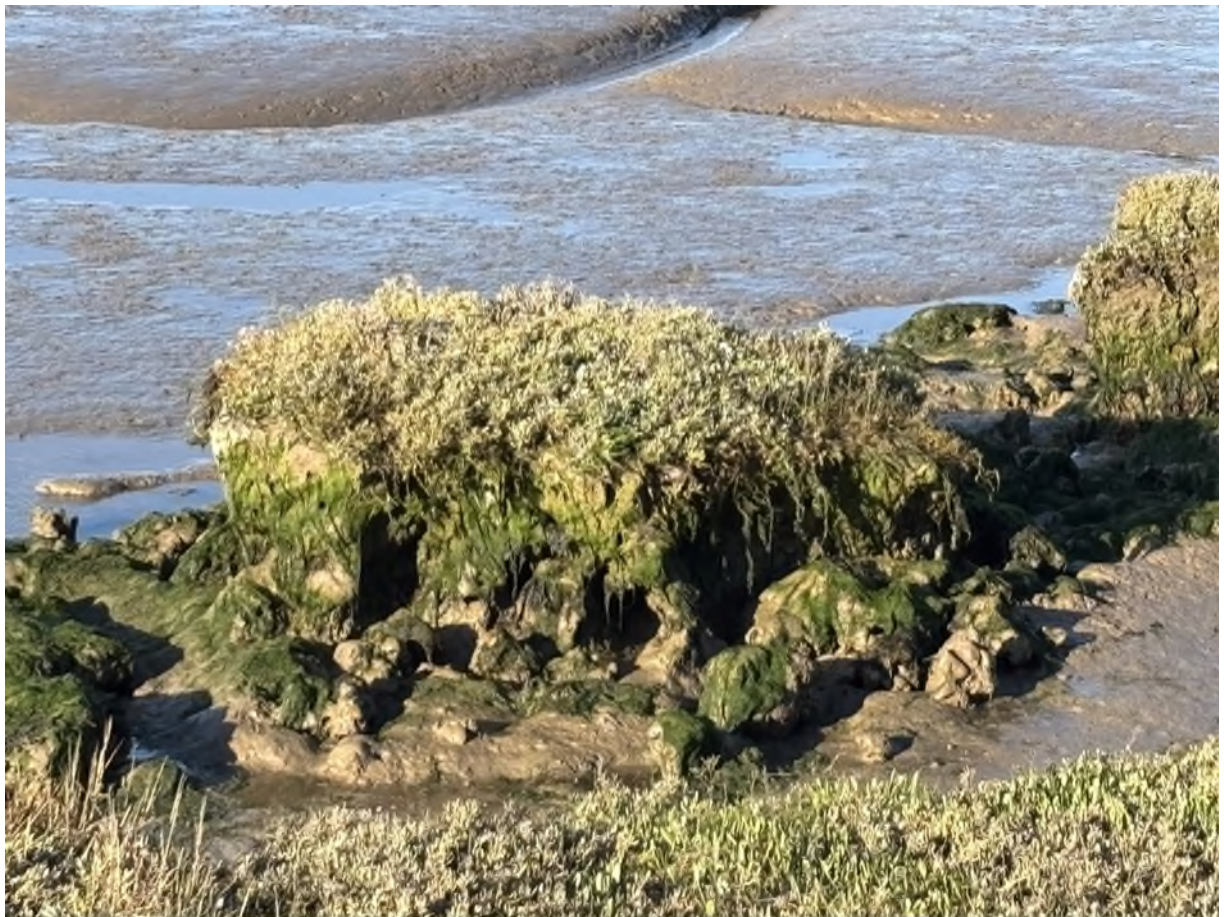
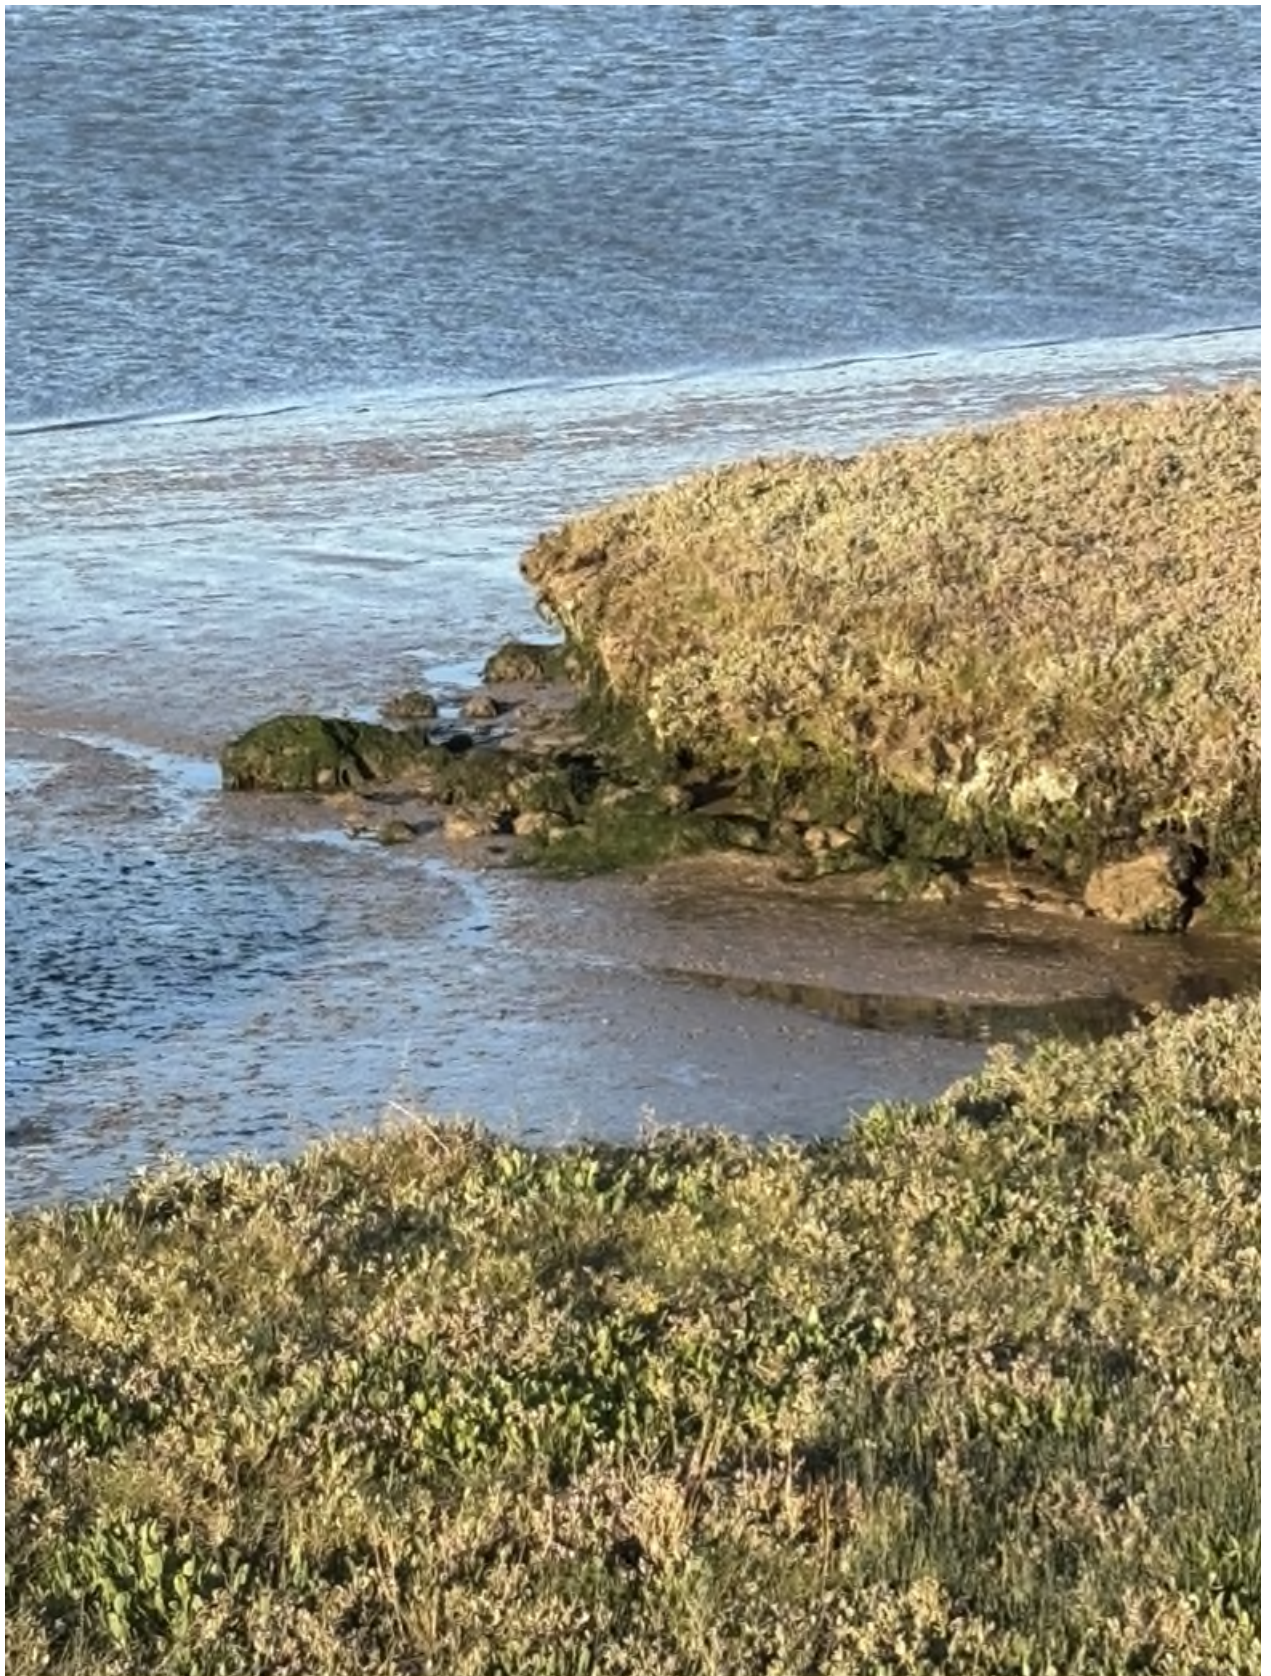
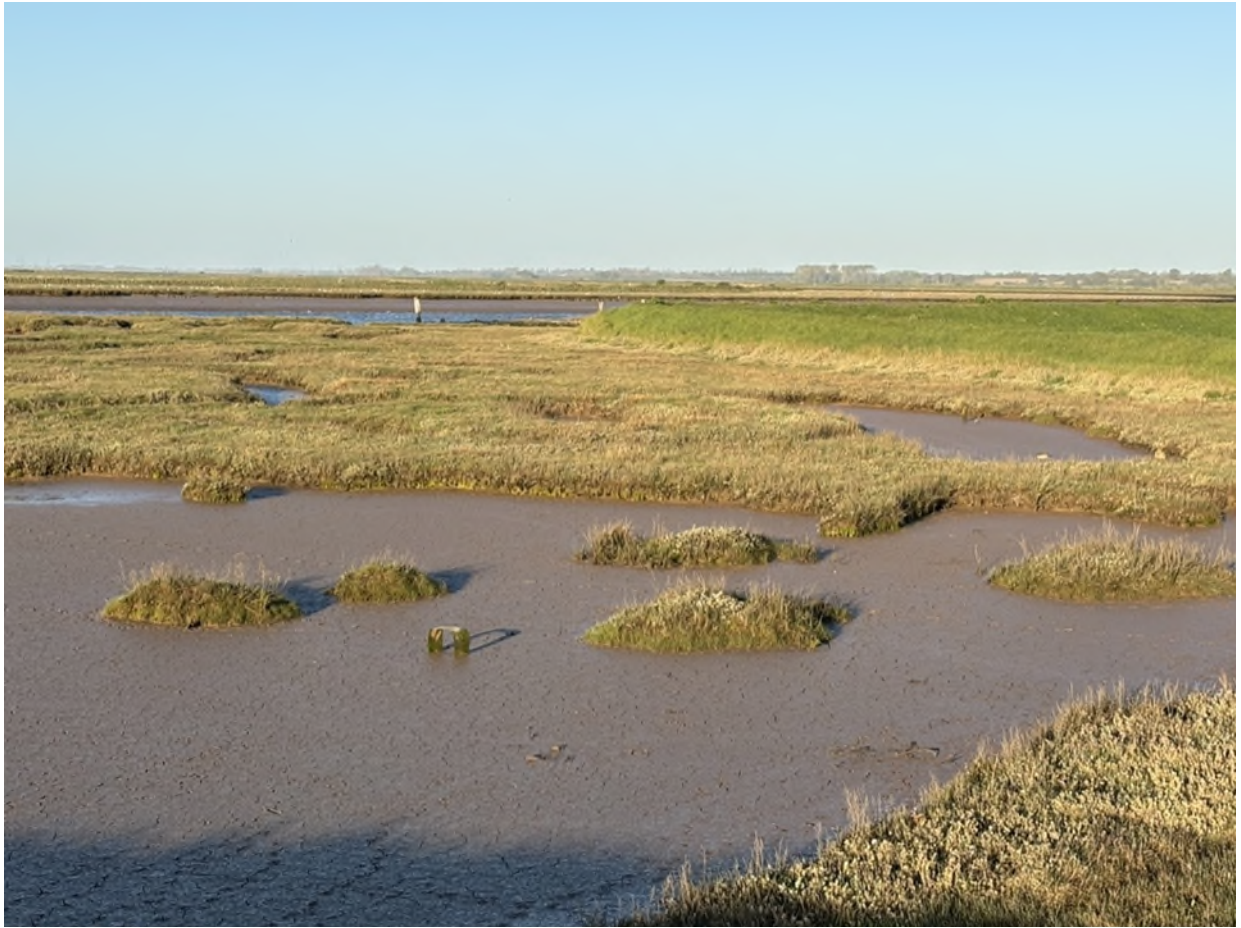
Each year it appears that the saltings are being eaten away; with the mud sections increasing in sizes. This is of course difficult to quantify on the basis of an annual visible inspection .
