# THE ALDE & ORE ASSOCIATION

## ALDE AND ORE ESTUARY ASSESSORS REPORT

| <b>FLOOD CELL:</b><br><br>FC4.3 | <b>AREA OF ASSESSMENT:</b><br><br>Pump House to Orford Town<br>TM 454536- TM427497<br><br>Walked Orford to Pump House, hence<br>comments in that order. |

## River Bank surveyed: Orford Town to Pump House TM427497 to TM454536

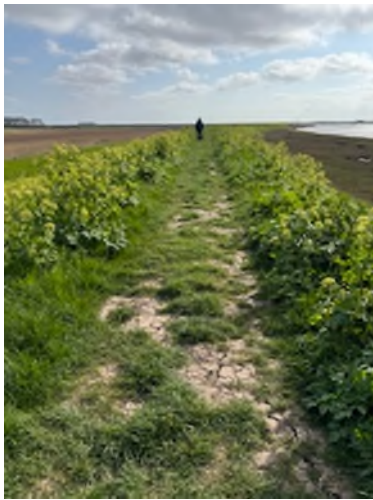
Heavy footfall wear from Orford Sailing Club to first gate : worn bare, little grass, extensive cracking See photo,

Then from gate for about 100 yards : also heavy wear and cracking, From then on grass growth stronger.

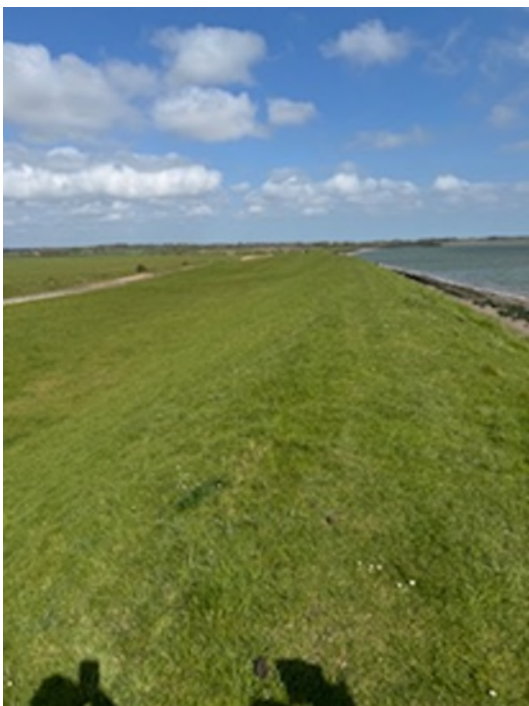
Apart from first 300 yards from Orford Sailing Club, the photo of 'box' below and last kilometre up to Pump, almost all the wall is in good condition (a mix of EA grade 2 and 3) and for part possibly merits Grade 1, see photo below

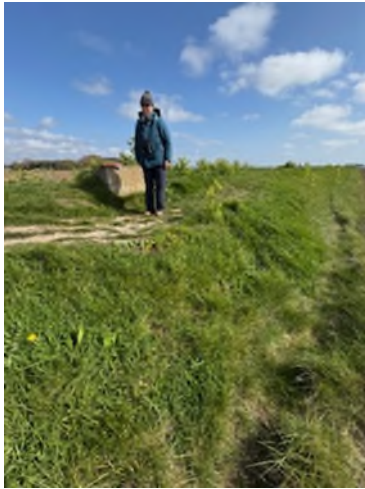
**Exception on Crest of wall:** worn path around stiles and old 'sluice concrete box' ? seen at about TM436497 where low (for 10 yards lower) along crest for about 150 yards from pipeline marker [TM435497] on the shore line to sluice box

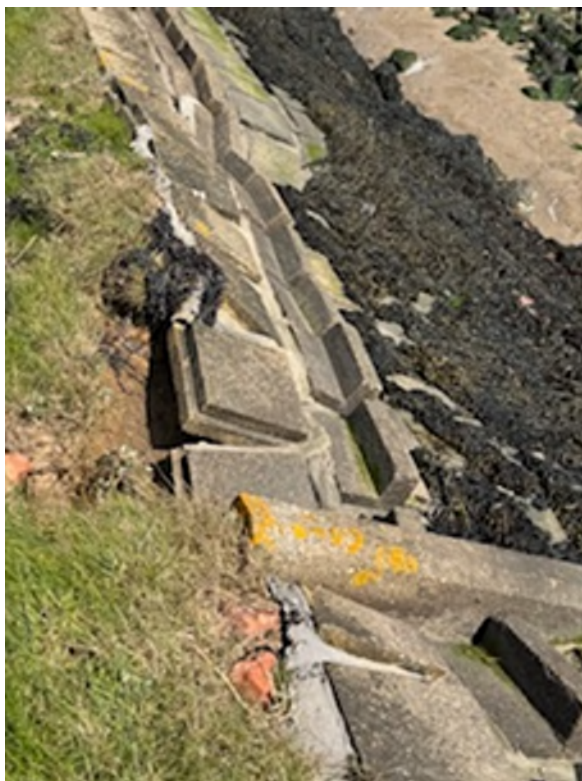
Example i

Except: i) small patch (a couple of blocks) just out of place (opposite Mast 3[TM422514])

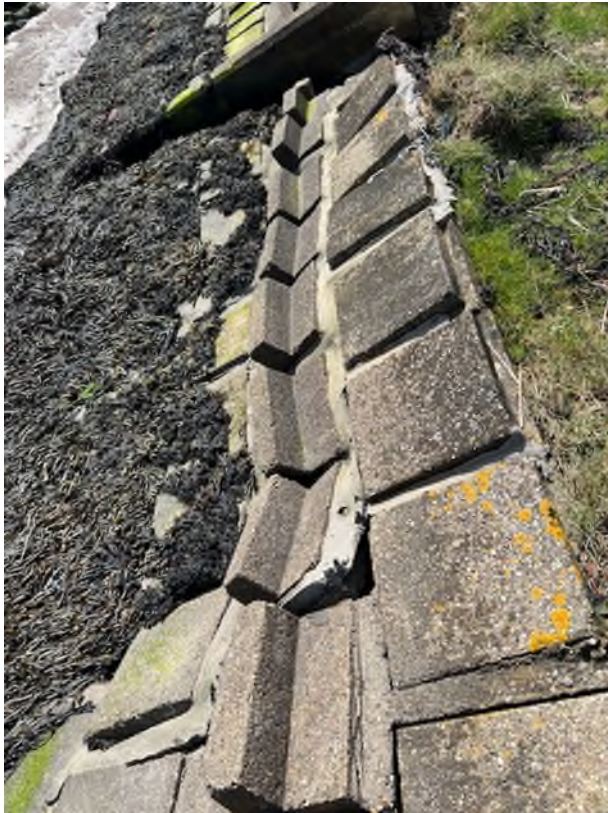
Example ii

ii) a stretch of about 3 metres where the wall is damaged. Evidence of repair to the grouting but not effective. Opposite Mast 2(TM 442516)

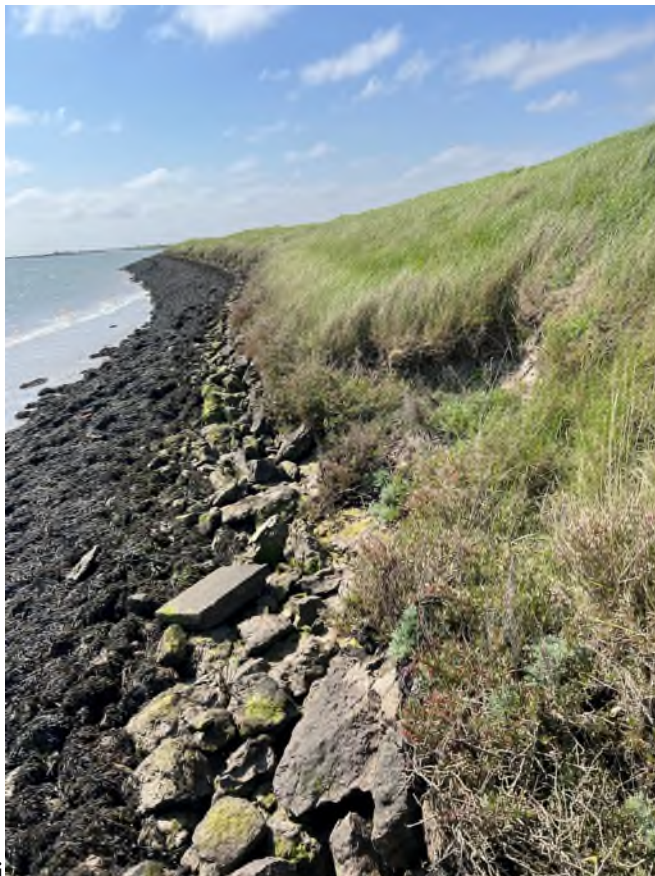
Example iii

iii) Grade 5 for 10 metres where only remnants of block work and tide line close to grass edges shown by seaweed on rubble rocks. and grass bank overhang being eroded .Opposite Mast 1 [TM442518]

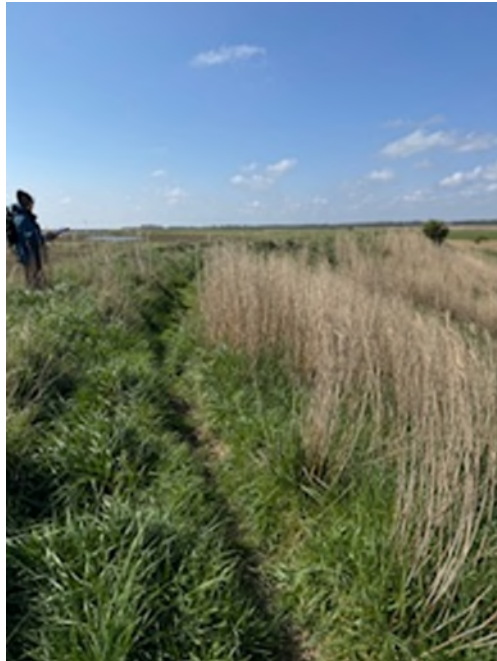
-- Also of concern at the south end of the 600m stretch, is about 200m stretch where the reeds, which normally only grow in the ditches below the walls, grew all the way up the walls to the crest particularly on the landward side, plus a bit on the river side last year, see photo below- - indicating it is very damp?, quite unlike any other vegetation growing on the walls.( too early in year to see if reeds growing as strongly in 2026) At this point the saltings on the river side are some 50-100 metres wide alongside the embankment so the chances of erosion and overtopping are limited to extreme events.TM453530 .
