# THE ALDE & ORE ASSOCIATION

## ALDE AND ORE ESTUARY ASSESSORS REPORT

| <b>NAME:</b><br><br><b>Alison Andrews</b><br><br><b>Keith Martin</b> | <b>DATE OF INSPECTION:</b><br><br><b>6 May 2026 10am-12noon.</b> |
| <b>FLOOD CELL:</b><br><br>FC5<br><br>Centre section only surveyed (Mann section) waiting landowner permission for other two sections to the north and south. | <b>AREA OF ASSESSMENT:</b><br><br>Mann section <i>see red lines on map below</i><br><br>TM 425564 east to TM431562 |

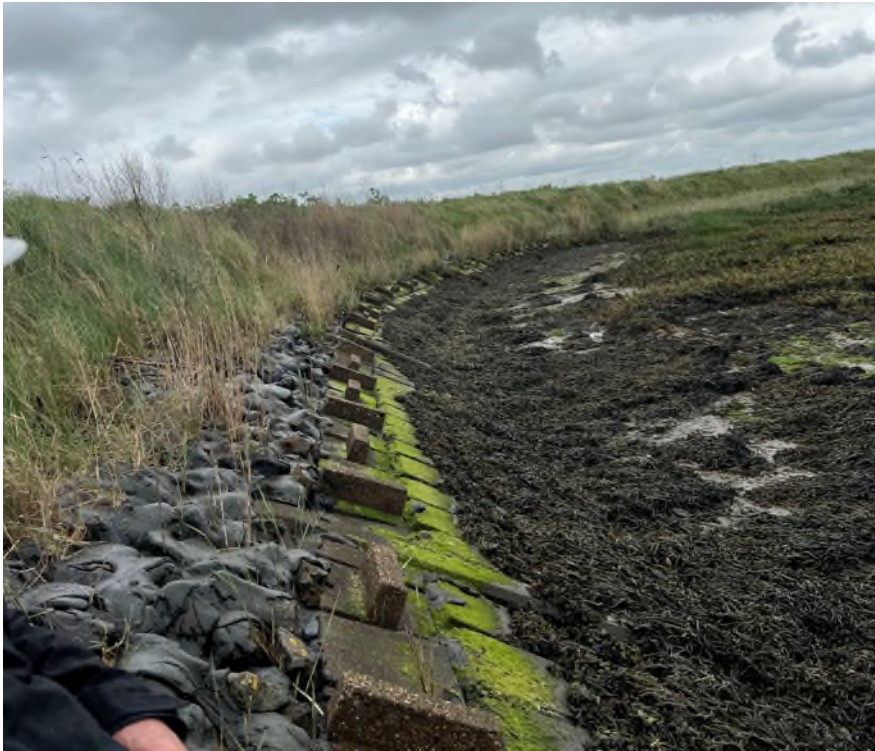
**Photo looking west from start of section TM426564** grass bank with salting vegetation just below the grassy bank ( no block work at this point), then wide channel with stretches of beaten down 426564 to TM 429563 the bank is lined with Essex blocks with a metre wide ledge above of large stones bound by generous layer of tarmac which look to be in reasonable order with some small

reeds growing through the tarmac.see photo.

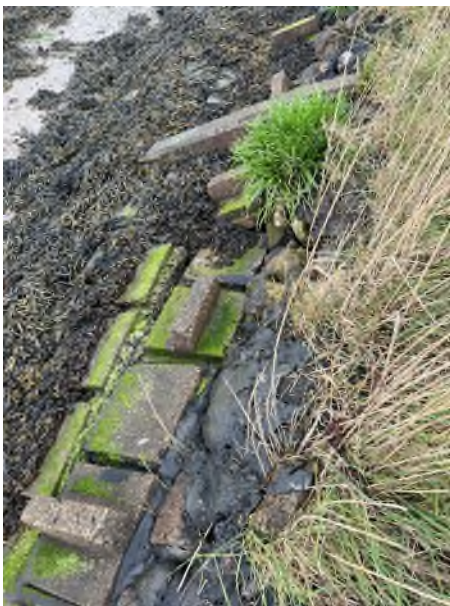
**T**owards TM429564 three or so small breakdowns of the Essex block below the tarmacked shelf .  
One with minor breakdown and grass in tarmac see below

Three spots where concrete block needs repair, well vegetated wall but is dense cow parsley crowding out grass a problem?

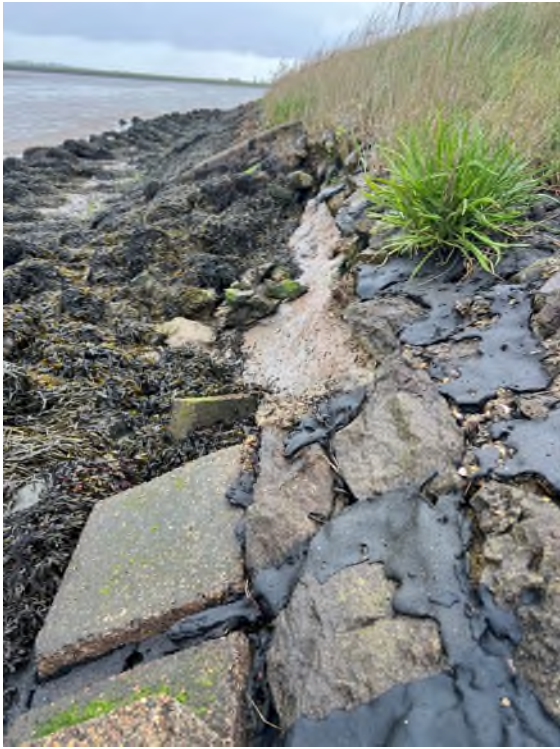
One exposing bare clay face, see below

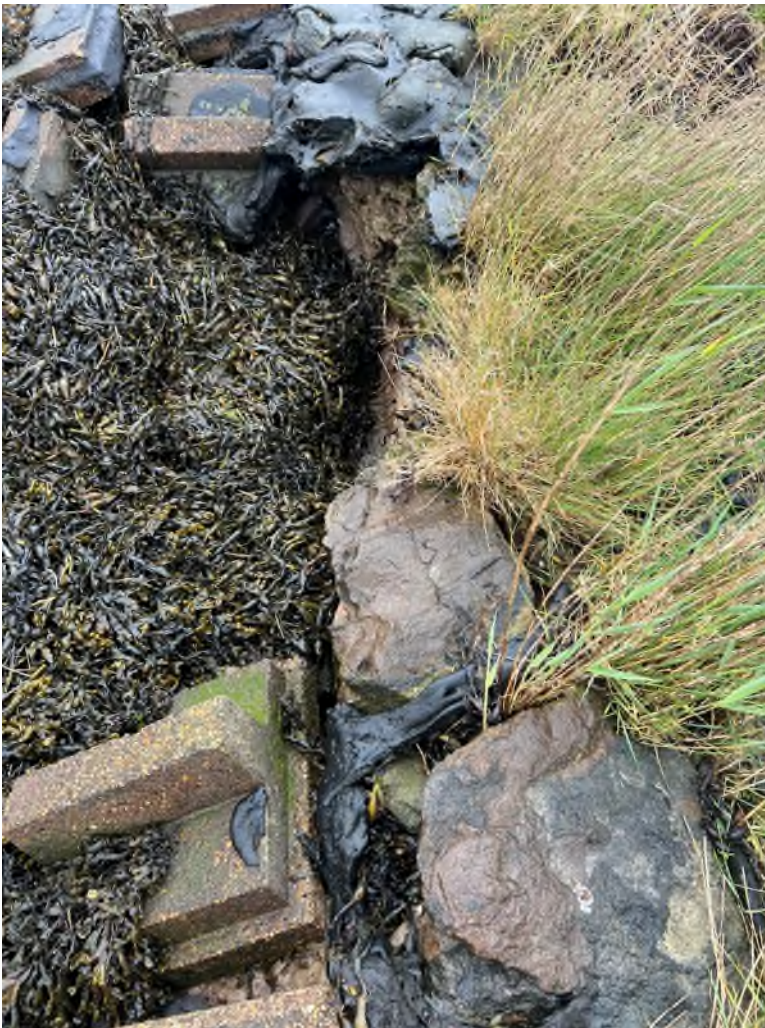
with the last one exposing a metre plus of river bank soil, see photo below

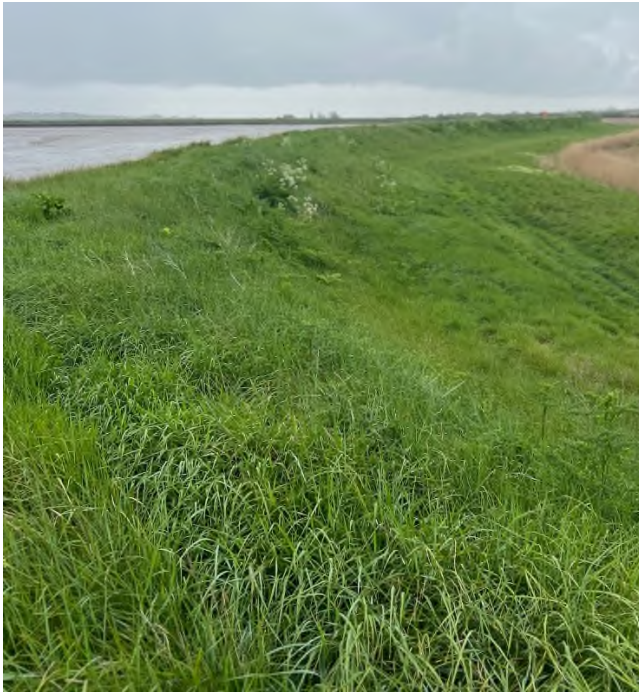
**Landward side bank** Heavily vegetated, a lot of tall grasses but particularly in parts 'cow parsley'

is dominant but no Alexanders. see photo, towards far end
