# THE ALDE & ORE ASSOCIATION

## ALDE AND ORE ESTUARY ASSESSORS REPORT

<b>NAME:</b> Alison Andrews ( with Roger Baxter and Simon Reed)	<b>DATE OF INSPECTION</b> April 2017
<b>LOCATION :</b> Brick Dock to Martello, river side TM 450565 to 463548 Part II SALTINGS report All map references from OS Explorer 212	<b>MARCH/Equinox Spring tide</b> <b>Note: Surge January 2017- strong North Winds on a 2.5 m surge on top of high tide may have contributed to winter damage</b>
<b>CO-ORDINATOR:</b> Amanda Bettinson	<b>Send to email: John Grayburn</b>

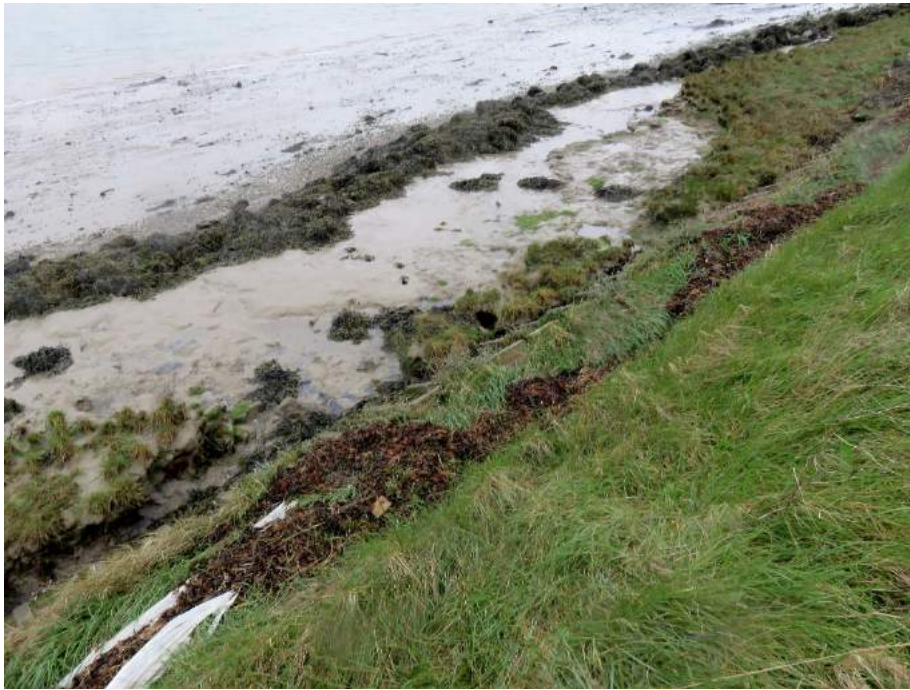
2016 Photo at TM 448555 below

1. At numerous points the saltings are also eroding at the edges. Photos from 2016 and 2017 near Chapmans Creek

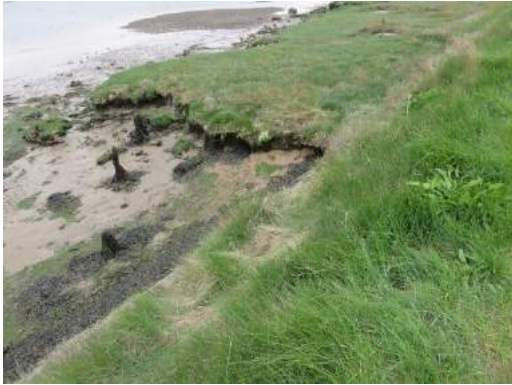
TM458557

2. Saltings to west of Aldeburgh sluice armour appear to have been eroded.

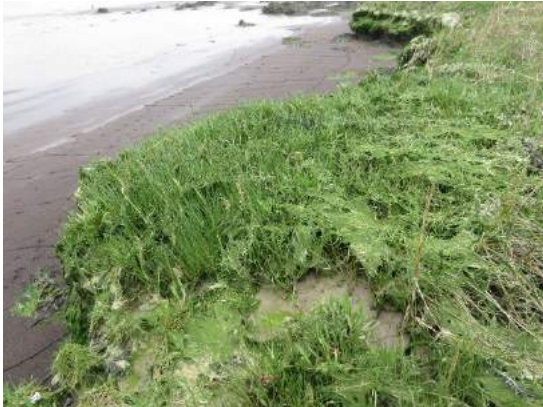
3. Algal slime. What seems to be a new appearance is some green algal slime deposited by the tide on top of the saltings which may be contributing to denudation or a feature of hard winter flows. Is it of concern?

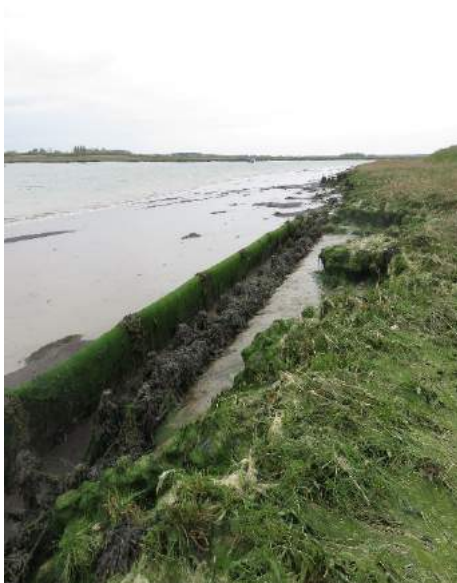
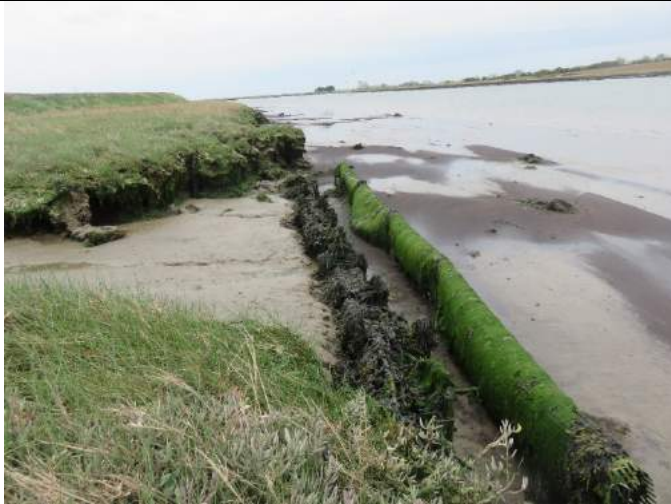
4. Longitudinal saltings pilot. TM 445556. A series of sections were installed using chestnut stakes and a mixture of tensar plastic and hazel wood bundles. The characteristics of the salting behind has changed and there are now mud only surfaces for one –three feet on the top of the saltings behind those zones. This needs consideration as the causes may be simple river flow or the impact of the large surge force on January.

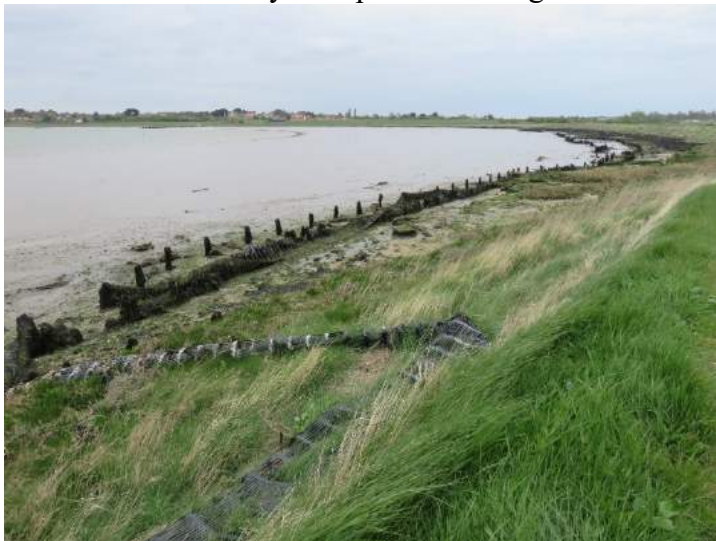
5. Brick Dock. TM 449564 Further failure of the pilot project tensor stretch, probably reflecting inability to cope with rolling waves resulting from long western fetch.
