ALDE AND ORE ESTUARY ASSESSORS REPORT

NAME:	Simon Reid Maggie Scorer	DATE OF INSPECTION:	5th April 2017
LOCATION:	Flood Cell 4-3		
AREA OF ASSESSMENT:	Orford to Pump House Sudbourne Marshes		March Equinox

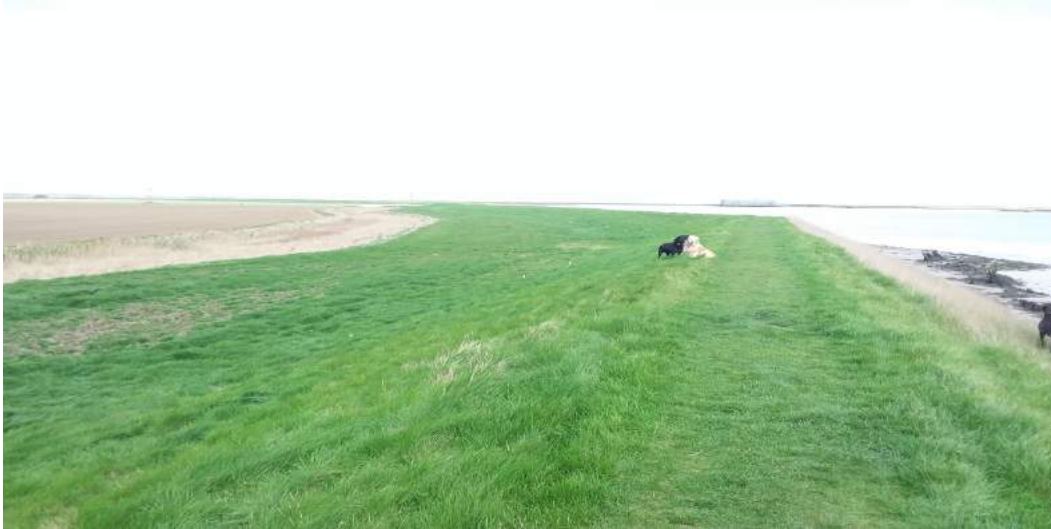
Photograph 1
(N 52 6.755 E 001 34.024)

River Wall/Armour	Saltings	High Tide Debris Line
Good front and back slopes with top of wall in good state, helped by sheep grazing (see Photograph 1)	Variable (see Photograph 2)	Generally well below top of wall

- River wall remains in good condition. Vegetation thick, assisted by sheep grazing.
- Saltmarsh variable in width.

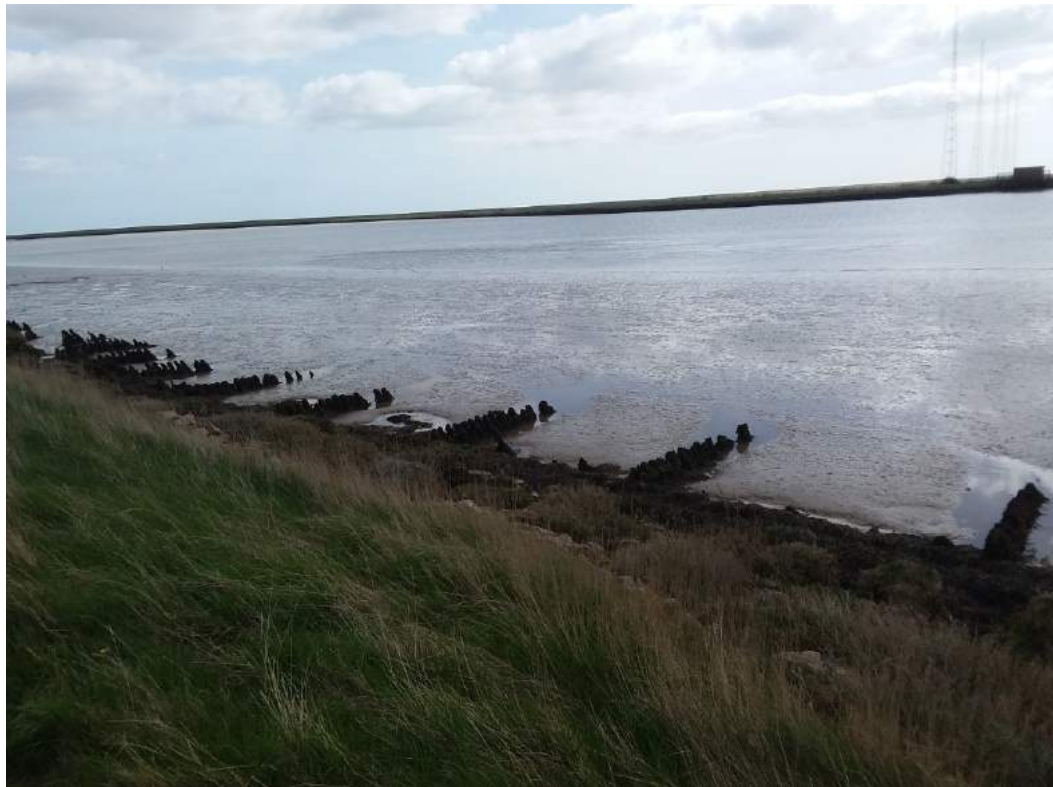
Photograph 2
(N 52 6.755 E 001 34.024)

Funding and design for restitution being arranged by the Saltmarsh Group and Environment Agency. Up to 1000m are vulnerable. The area of distinct erosion is a priority to avoid wave action on river wall.
