# THE ALDE & ORE ASSOCIATION

## ALDE AND ORE ESTUARY ASSESSORS REPORT

<b>NAME:</b>	Tim Dudgeon Peter Donaldson	<b>DATE OF INSPECTION:</b>	31st March 2017
<b>LOCATION:</b>	Flood Cell 8		Very low tide
<b>AREA OF ASSESSMENT:</b>	Ham Creek Marshes		March Equinox

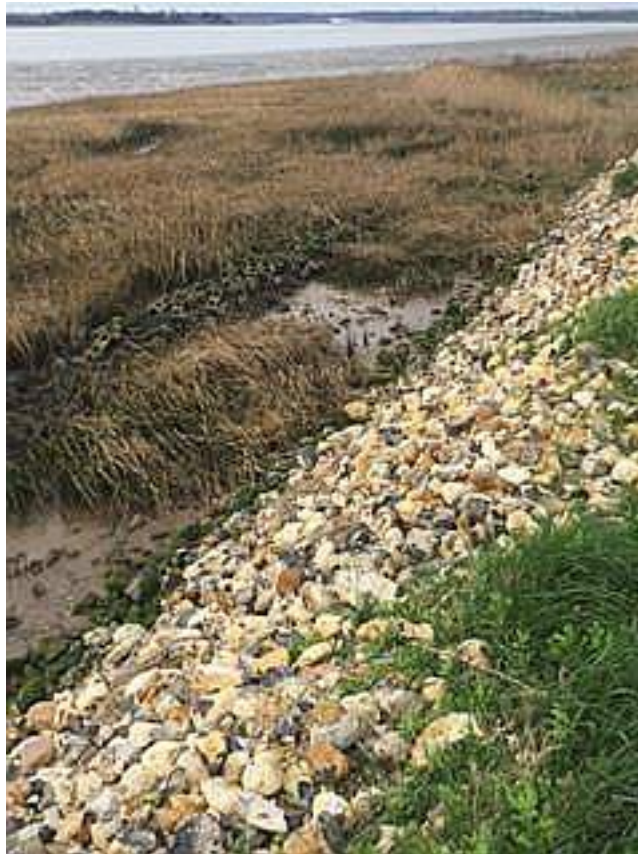
Photograph 1

River Wall/Armour	Saltings	High Tide Debris Line
Good condition [see Photographs 1 & 3]	Deep and shallow sloping beach	No evidence, debris at foot of wall (see Photograph 2)
