THE ALDE & ORE ASSOCIATION

ALDE AND ORE ESTUARY ASSESSORS REPORT

NAME[S]: Simon Reid Sue Ingham	DATE OF INSPECTION: 27 March 2020
FLOOD CELL: FC4.4	AREA OF ASSESSMENT: Pump House to Chapmans Creek

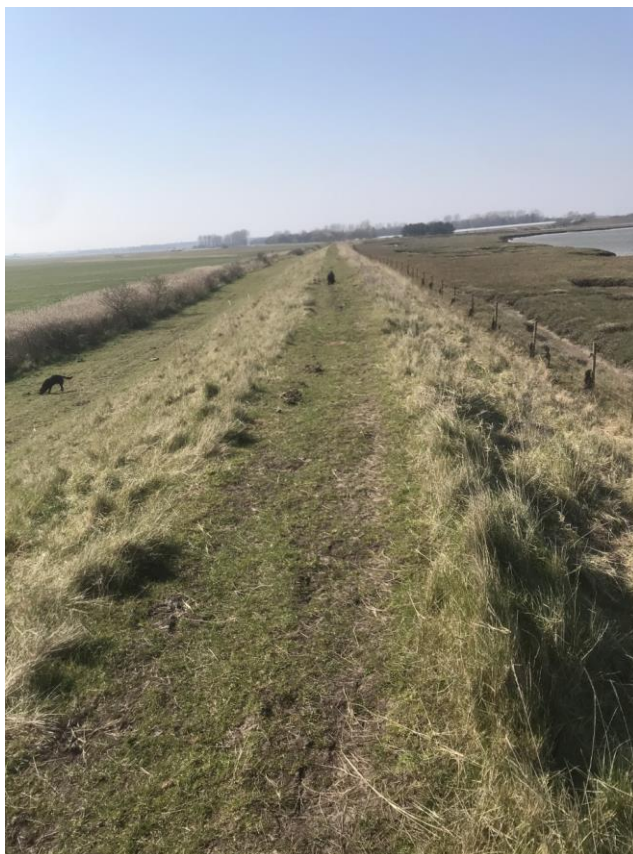
Photo 1

Grid Ref: 453 550 to 458 553

River wall well covered in vegetation, except where horses have caused extensive compaction at above location.

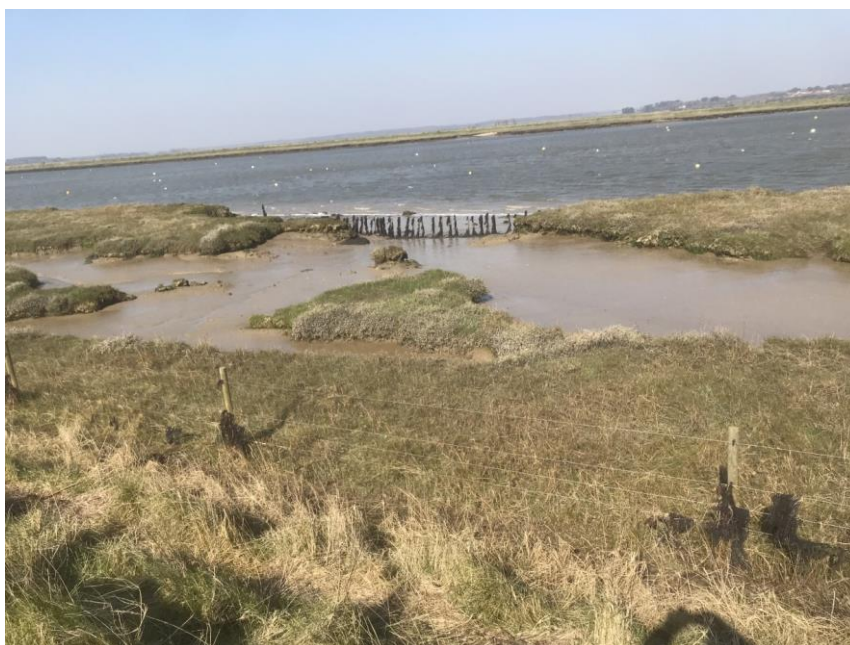
Photo 2

Grid Ref: 459 553

Generally river wall in good shape on both front and back slopes – but netting has come away from stakes on the attenuation system at 459 553.

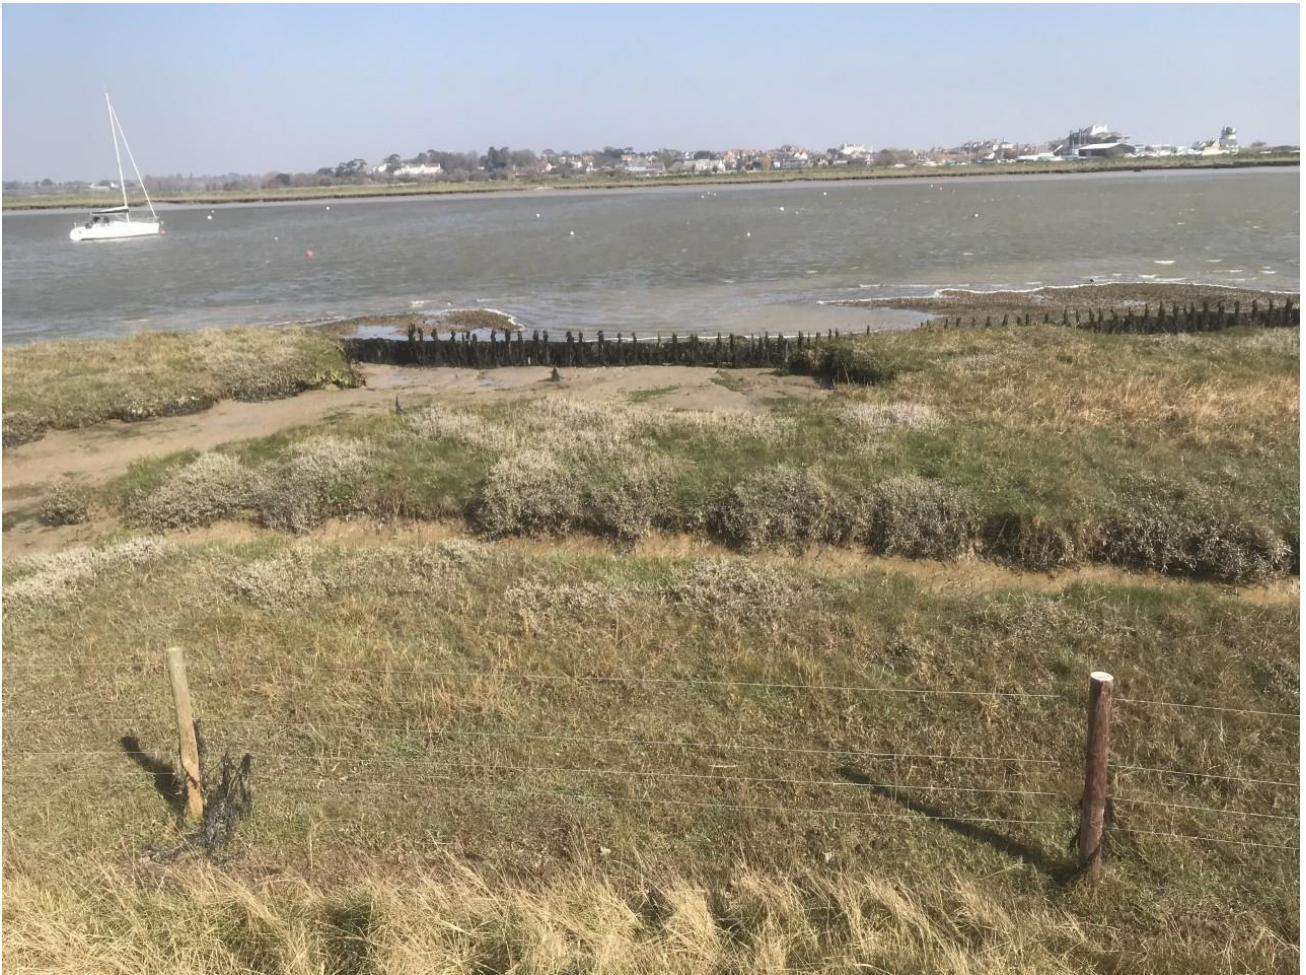
Photo 3

Grid Ref: 460 553

Whereas netting still in place at 460 553.
