THE ALDE & ORE ASSOCIATION

ALDE AND ORE ESTUARY ASSESSORS REPORT

NAMES: R Baxter J Evans	DATE OF INSPECTION: September 2020
FLOOD CELL: FC7	AREA OF ASSESSMENT: Snape Bridge to Blackheath

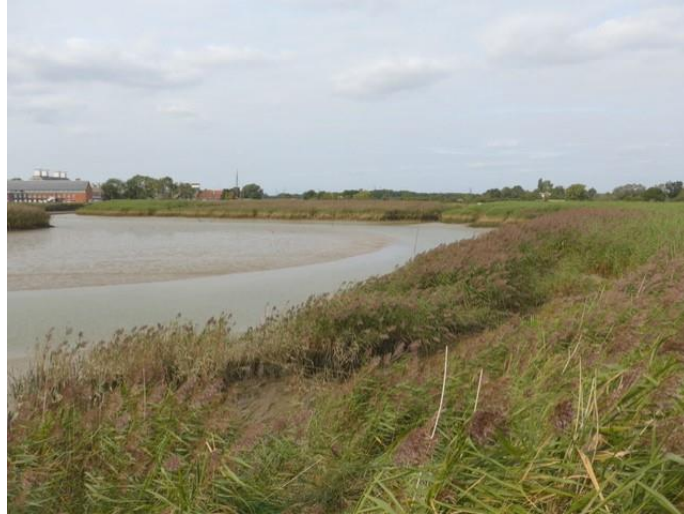
Photo 1

Considering the high foot traffic on this popular walk, the upgraded wall from the bridge to Snape Warren is stable. The slopes are well covered in vegetation.

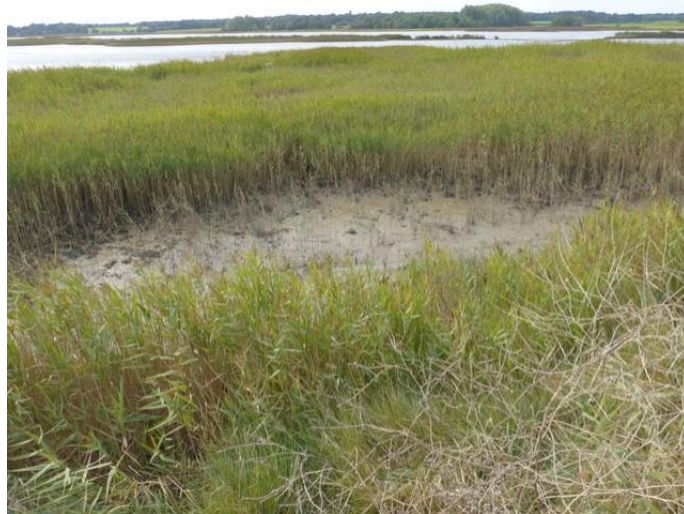
Photo 4

Halfway along this stretch is an area where the reeds have not grown. These were highlighted by Caron and Victoria in the previous year's report.

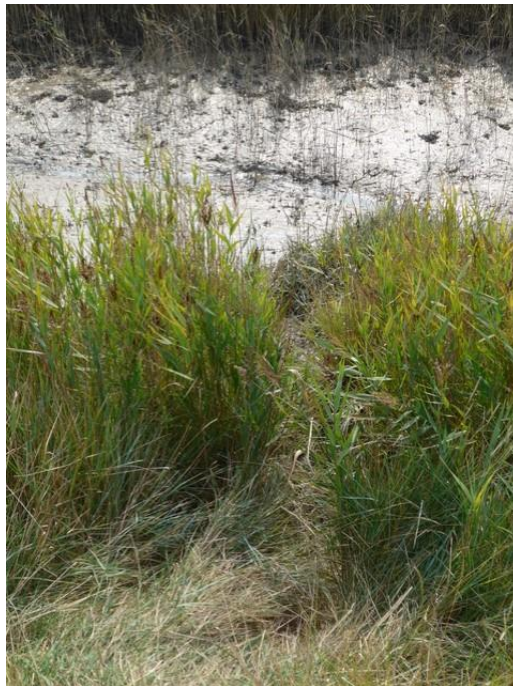
Photo 5

There appears to be a run-off from the marshes on the north side at the base of the wall which runs into a parallel channel.

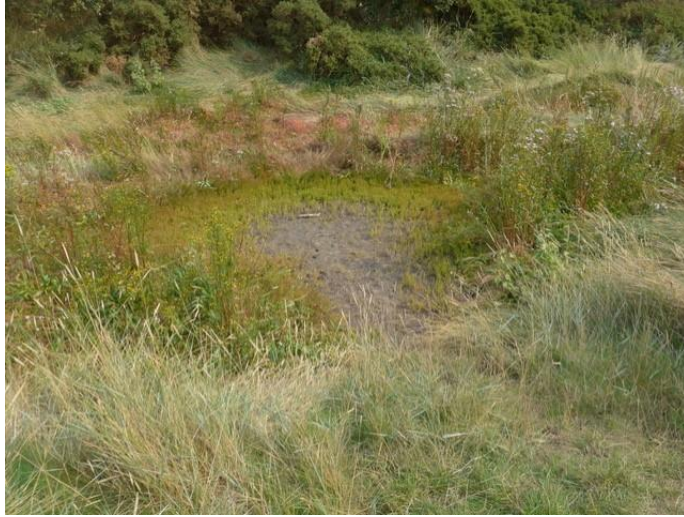
Photo 6

Further downstream – and around the lower end of Snape Warren – the path continues along the deep marshes which are covered during spring high tides.

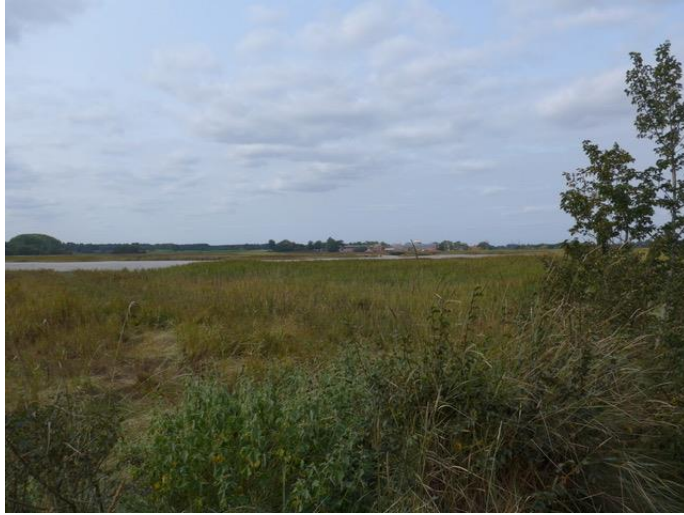
Photo 9

One area is often damp, but of no concern as the ground rises all the way round New England fields to the Blackheath estate.
