THE ALDE & ORE ASSOCIATION

ALDE AND ORE ESTUARY ASSESSORS REPORT

NAME: R Baxter	DATE OF INSPECTION: 24 April 2020
FLOOD CELL: FC9	AREA OF ASSESSMENT: Brick Dock to Hazlewood Marshes

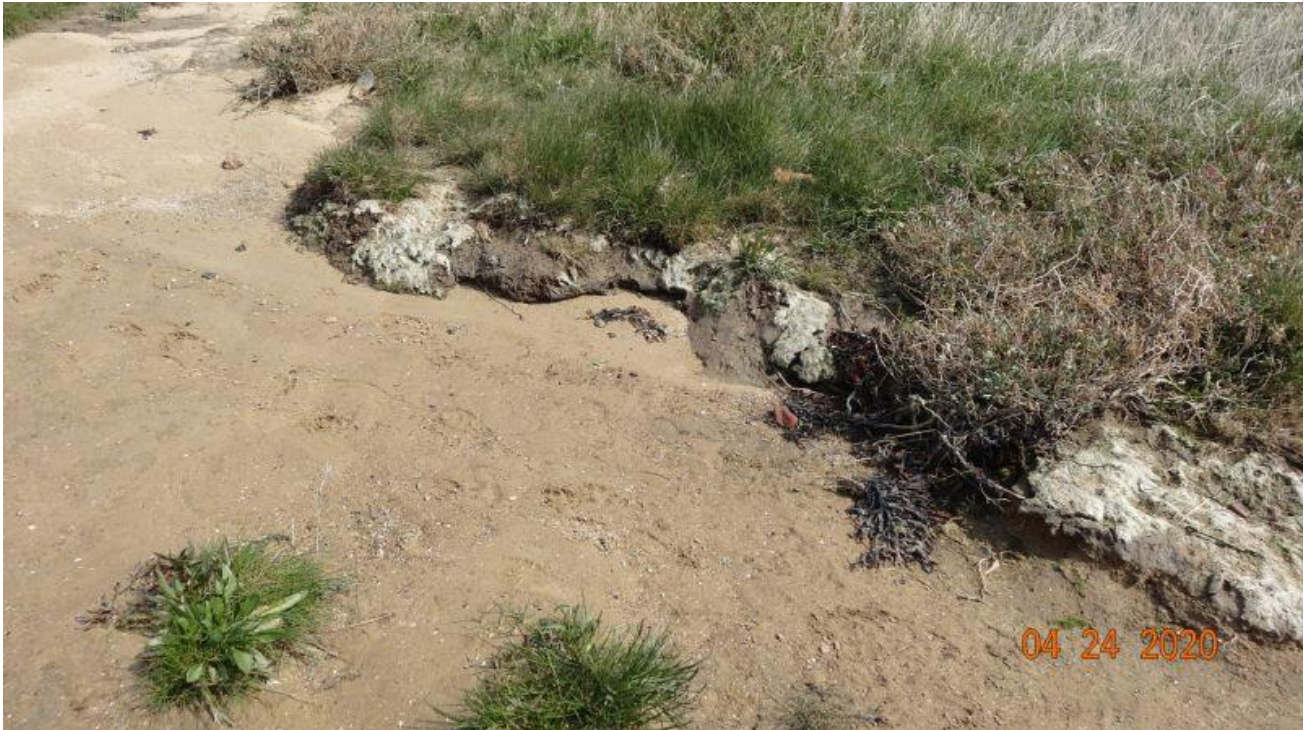
Photo 1

River wall at the dock end is in good repair with good vegetation on saltings in places.

Vegetation root washout continues where there is a sandy base, but this does not appear to be a serious problem.

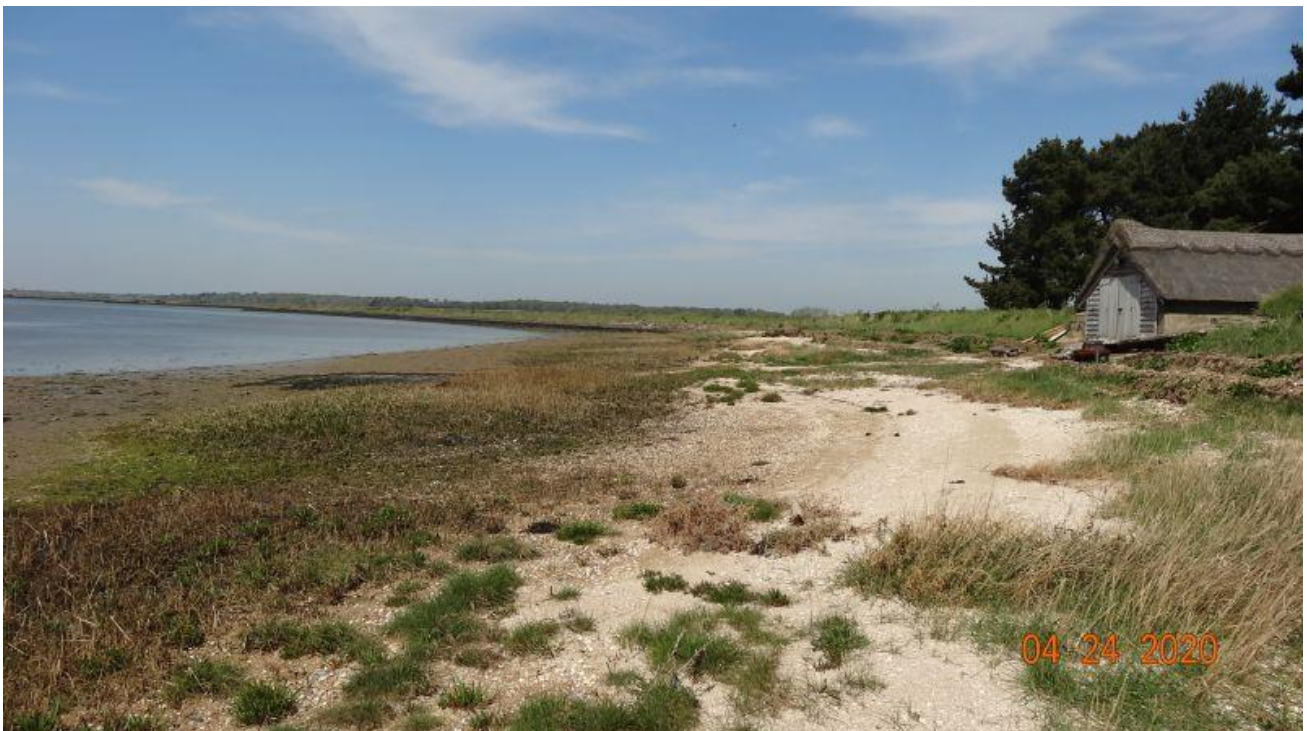
Photo 2

Saltings are deeper towards Round Hill and in good condition .

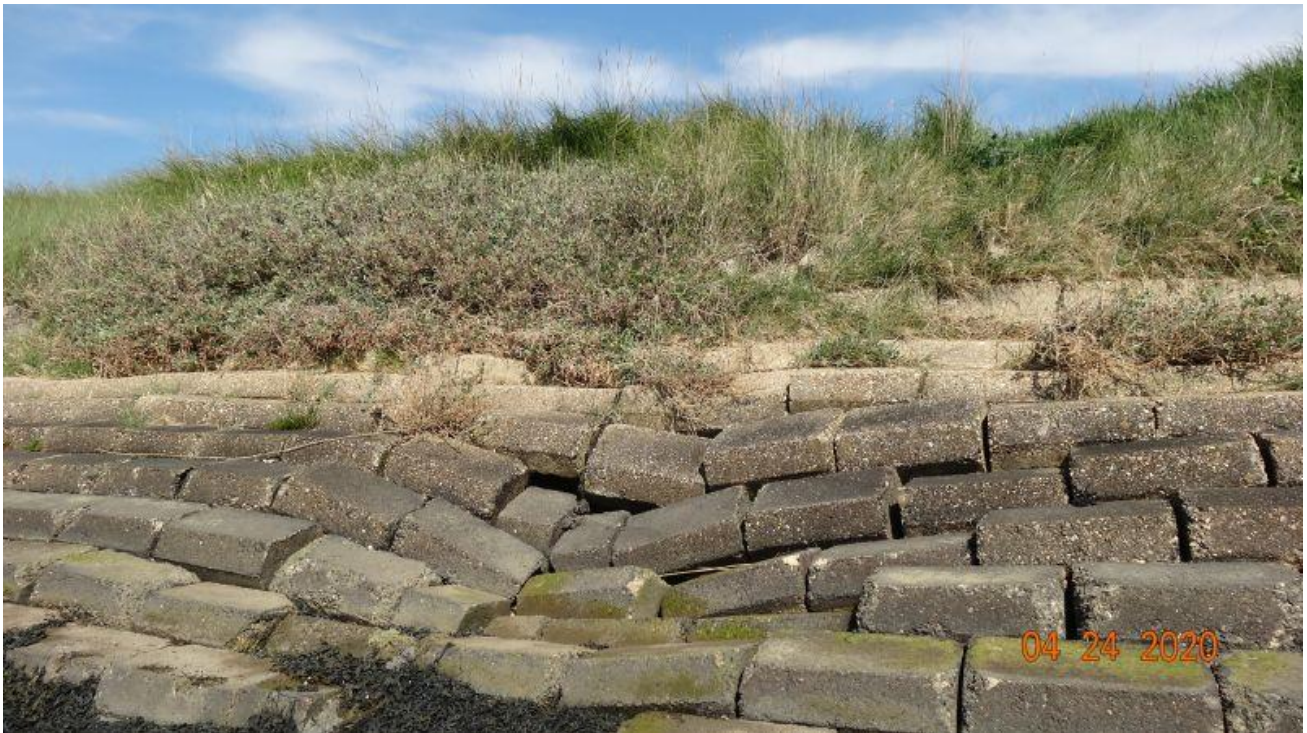
Photo 3

The revetment work is breaking up in places with some significant erosion at the water line.
Requires EA inspection sometime.

Should a breach occur in the future, the area to be flooded would be downstream of Hazlewood marsh and flood the lower half of the Round Hill meadow and adjoining areas of the golf course.

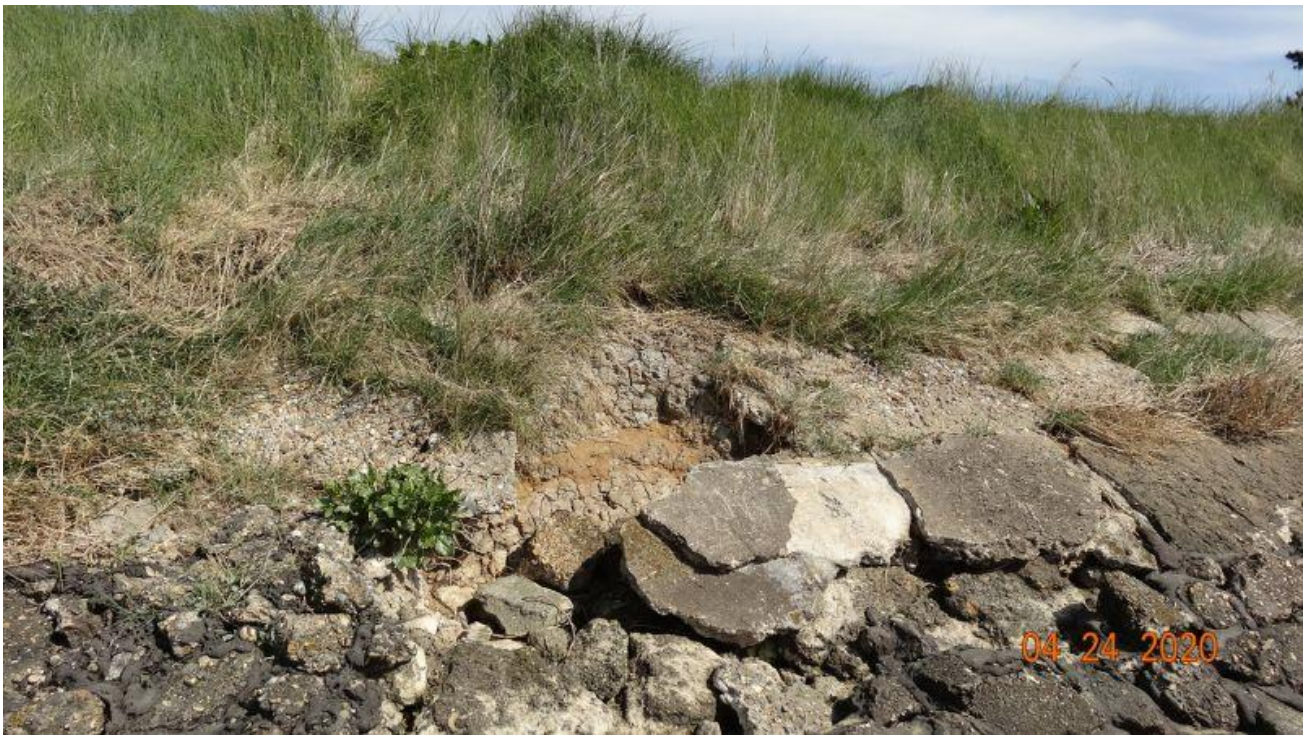
Photo 5

The back and front slope debris line are the same height as a result of the winter surge which flooded this area from the Hazlewood breach.
