# THE ALDE & ORE ASSOCIATION

## ALDE AND ORE ESTUARY ASSESSORS REPORT

| <b>NAME:</b><br><b>Bobby and Sue Rusack</b> | <b>DATE OF INSPECTION:</b><br><br>5 <sup>th</sup> May 2026 |
| <b>FLOOD CELL:</b><br><br>FC4-4<br>Started at Blackstakes 200 meters<br>downstream | <b>AREA OF ASSESSMENT:</b><br><br>Pump House to Chapmans Creek |

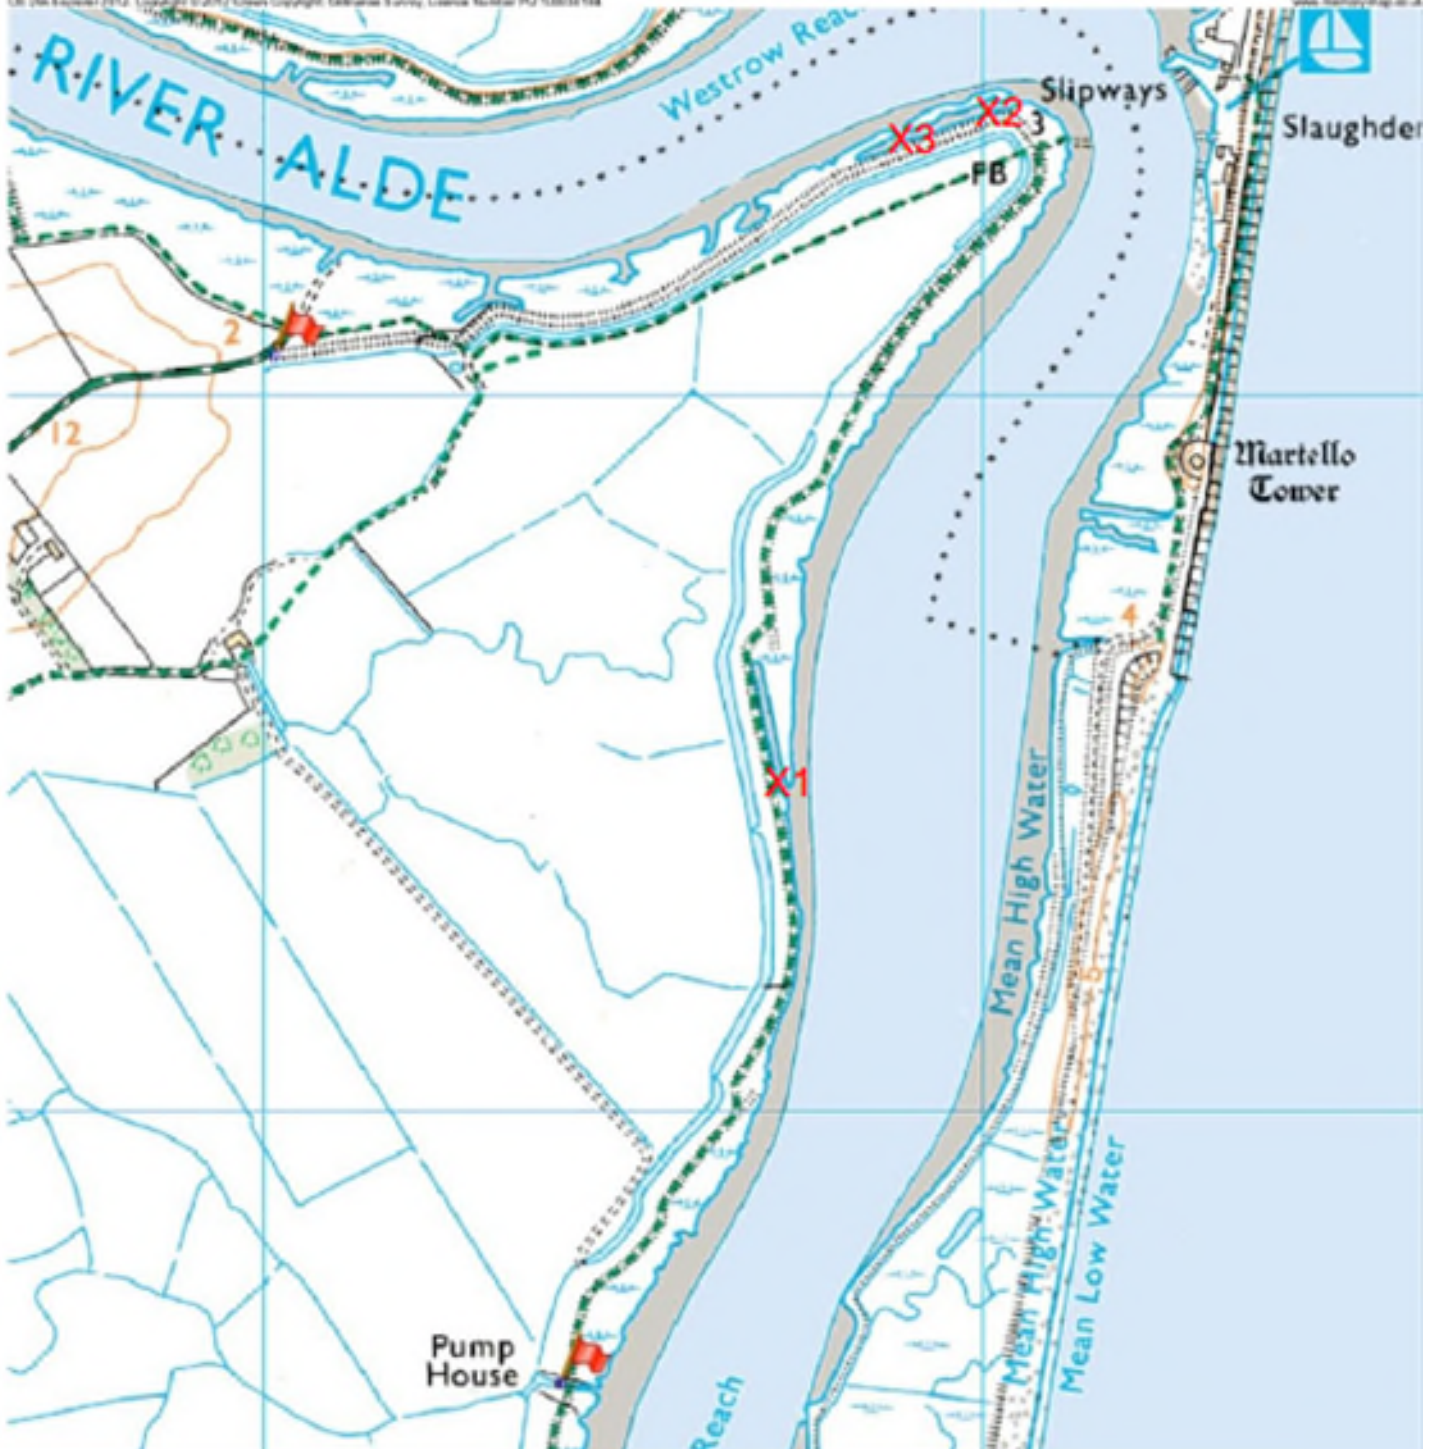
**See Page 2**

**River Bank surveyed:**

**There are three places with poor saltings defence crosses marked on the map along with photographs.**

I suggest that flood cell three is reduced to only up to the footpath Mark and that 4.3 is extended as see attached map.

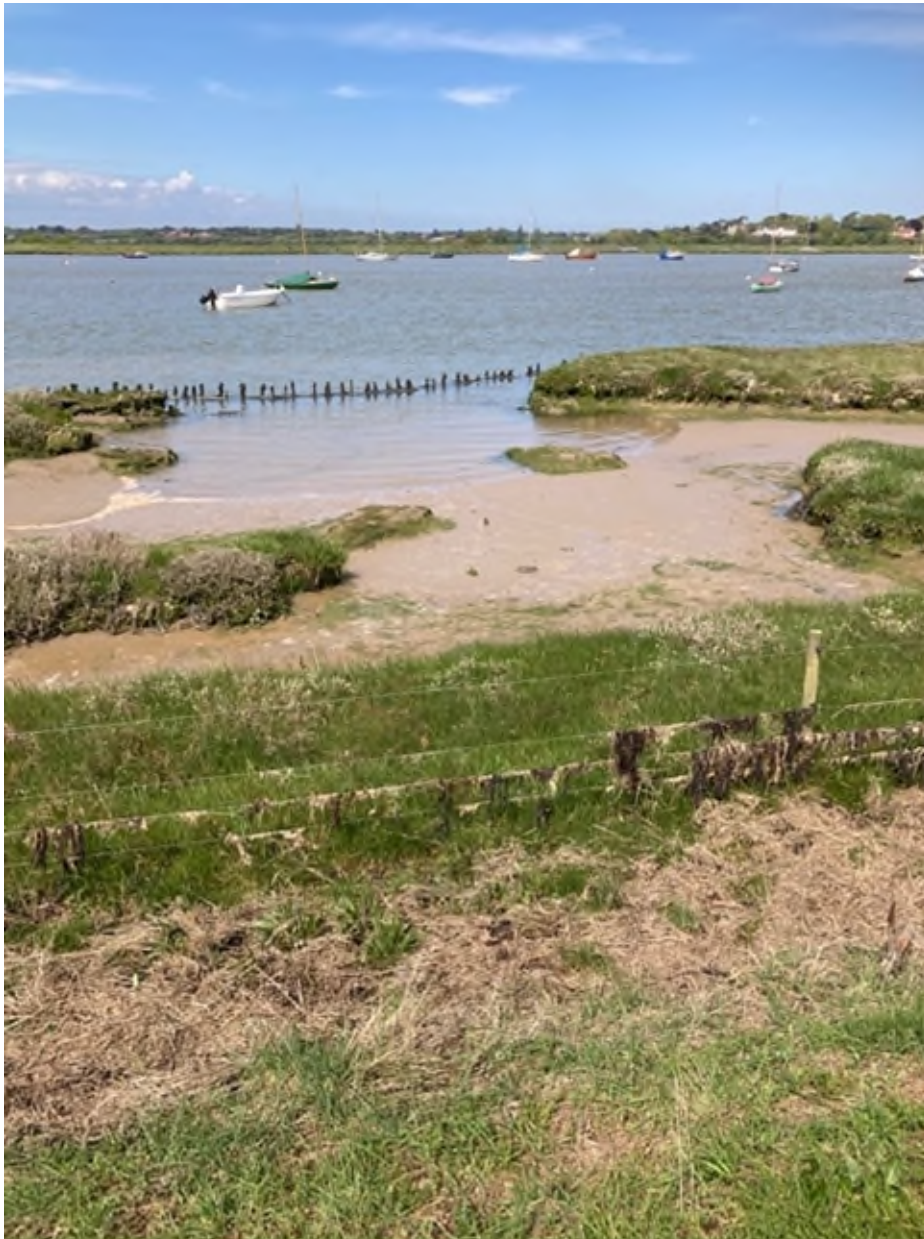
**Location X3**

Note debris from high tide has gone through the fence line
