THE ALDE & ORE ASSOCIATION

ALDE AND ORE ESTUARY ASSESSORS REPORT

NAME:	Tim Dudgeon John Grayburn Roger Baxter Peter Donaldson Simon Reid	DATE OF INSPECTION:	March 2016
LOCATION:	Flood Cell 8	March Equinox	
AREA OF ASSESSMENT:	Blackheath Estate, Ham Creek

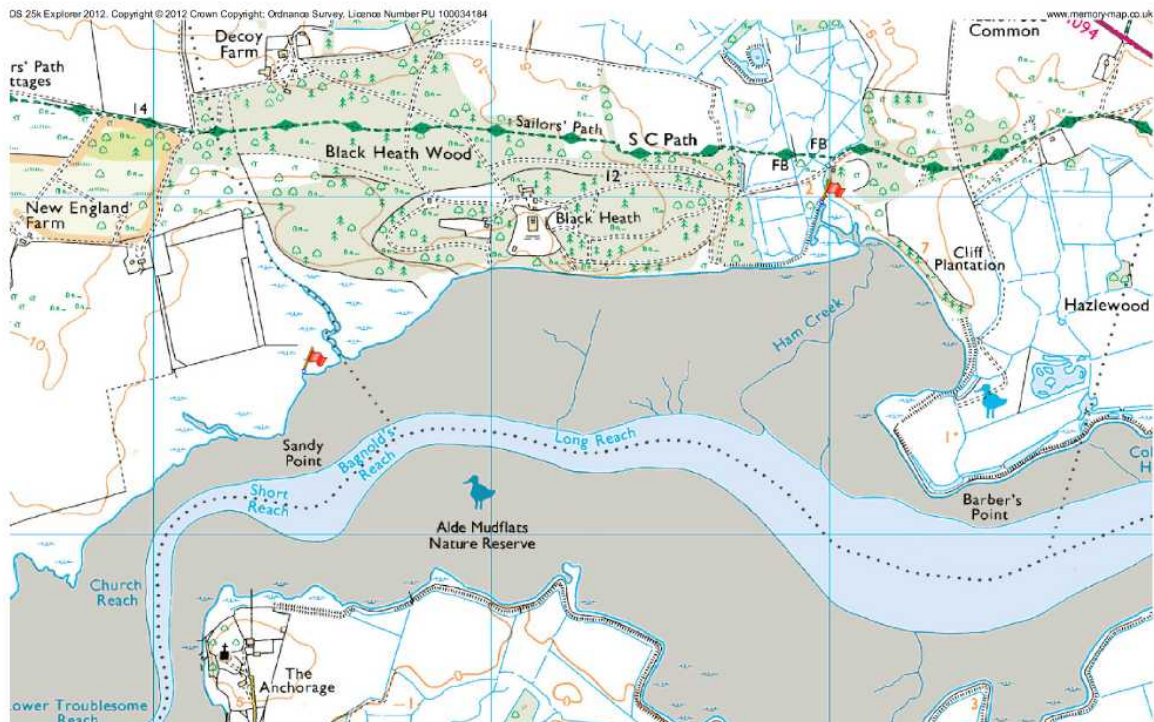
River bank surveyed

River Wall/Armour	Saltings	High Tide Debris Line
Good	Deep with shallow sloping beach	No evidence

- Upstream – mostly deep and shallow sloping beach and saltings, with no overtopping likely as the ground rises well into the estate.
- Some vertical cliff erosion has taken place east of the main house – again, no concern as the ground continues to rise behind.
- In the Ham Creek area, the river wall has good vegetation and no signs of overtopping. The reinstated section by the creek and sluice is holding well and vegetation continues to grow. Western area is suffering toe erosion behind the broken armour. Matting is currently being anchored to the back slope, as it is planned to strengthen the wall with rock armour and eventually raise the wall height to about 2.7m in order to be above surge height.
- Saltings and beach are in good order.
