# THE ALDE & ORE ASSOCIATION

## ALDE AND ORE ESTUARY ASSESSORS REPORT

<b>NAMES:</b> Brian Johnson Susan Bowerman Clare Goodchild	<b>DATE OF INSPECTION:</b> 10th, 17th April & 1 <sup>st</sup> May 2018
<b>LOCATION:</b> Flood Cell 1	<b>AREA OF ASSESSMENT:</b> Shingle Street to Butley Mills (Boyton & Butley Marshes)

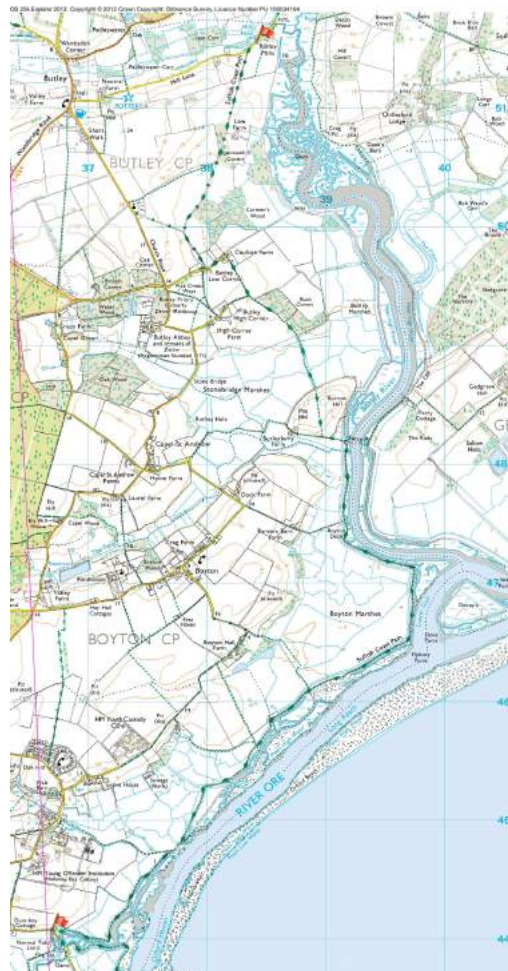
Mouth of Barthorpes Creek: The gradual breakdown of levee below pillbox - reported each year since 2014 - has been made good since last report with rock armouring (see photograph). Adjacent salting to north broken up by recent severe gales, shingle overtopped onto salting (see photos 1 and 2).
