THE ALDE & ORE ASSOCIATION

ALDE AND ORE ESTUARY ASSESSORS REPORT

NAMES: Simon Barrow Keith Martin	DATE OF INSPECTION: 9th April 2018
LOCATION: Flood Cell 5	AREA OF ASSESSMENT: Chapmans Creek to Anchorage, Iken

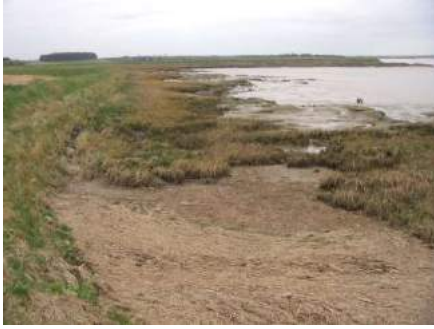
567 438	Serious damage to armour and several to the west of it	Stakes worn	1.0 metres
----------------	---	--------------------	-------------------

2018 - 567438 – looking west – salting damage

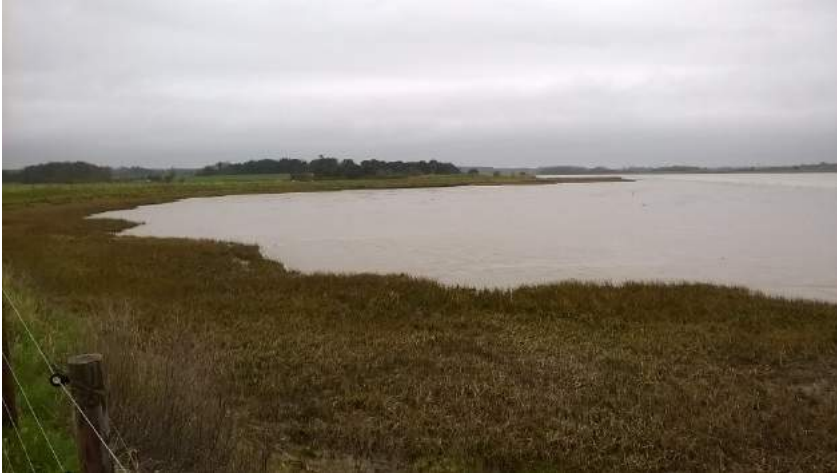
looking west

Tippers R us – clay storage??
