# THE ALDE & ORE ASSOCIATION

## ALDE AND ORE ESTUARY ASSESSORS REPORT

<b>NAMES:</b> South Section: Susan Bowerman Clare Goodchild.  North Section: Brian Johnson Jonathan Evans Richard Kihl	<b>DATE OF INSPECTION</b> South section 2 May 2019  North Section 24 April 2019
<b>LOCATION:</b> Flood Cell 1	<b>AREA OF ASSESSMENT:</b> Shingle Street to Butley Mills (Hollesey, Boyton & Butley Marshes)

## **FLOOD CELL 1 – SHINGLE STREET TO BUTLEY MILLS - SOUTH**

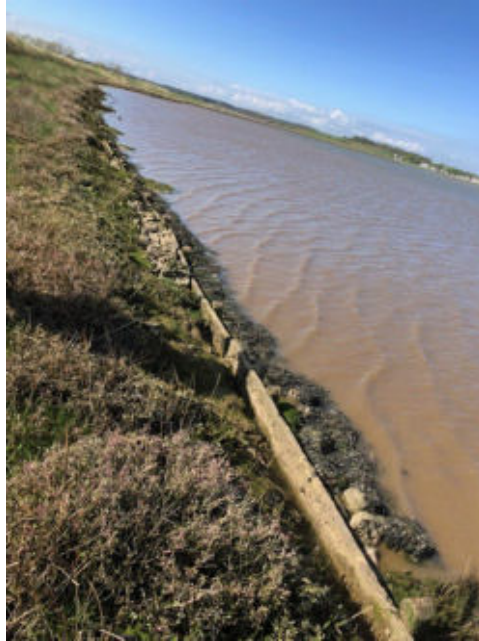
From Boyton Dock to northern extent of the bank the angles of banks are satisfactory for river side protection and landward sustainability. It is protected by saltings of variable width except for short length from 395497 to 394498 where the foot of this stretch is protected by dilapidated timber timber boarding. (see photo) It should be noted that there is no concrete armouring on the whole of this length except for short length around 396488. There is no footpath or permissive path on this section.
