# THE ALDE & ORE ASSOCIATION

## ALDE AND ORE ESTUARY ASSESSORS REPORT

<b>NAME:</b> Roger Baxter	<b>DATE OF INSPECTION:</b> April 2019
<b>LOCATION:</b> Flood Cell 9	<b>AREA OF ASSESSMENT:</b> Brick Dock

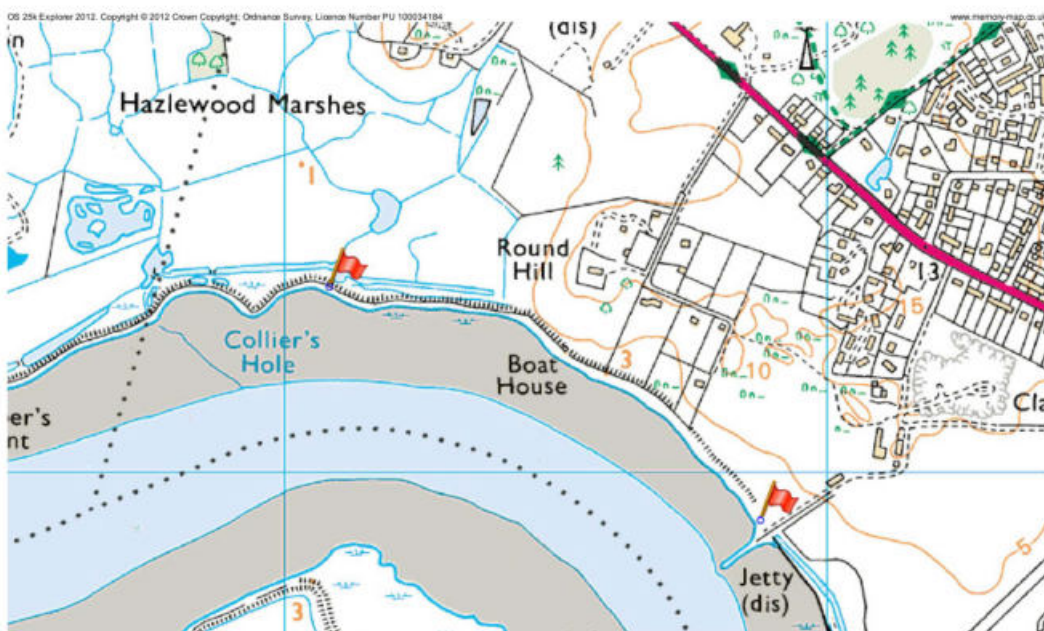
### River Bank Surveyed:

River Wall/Armour	Saltings	High Tide Debris Line
Beach with thick vegetation behind.. Broke armour upstream has not changed.	Lower vegetation in sand suffering from tidal erosion on sand. Further upstream, saltings are deep but covered during high tide.	Low level
