# THE ALDE & ORE ASSOCIATION

## ALDE AND ORE ESTUARY ASSESSORS REPORT

<b>NAME[S]:</b> A Andrews +	<b>DATE OF INSPECTION:</b>  31 March 2020 and mid April
<b>FLOOD CELL:</b>  FC10	<b>AREA OF ASSESSMENT:</b>  Slaughden Quay to Brick Dock Jetty

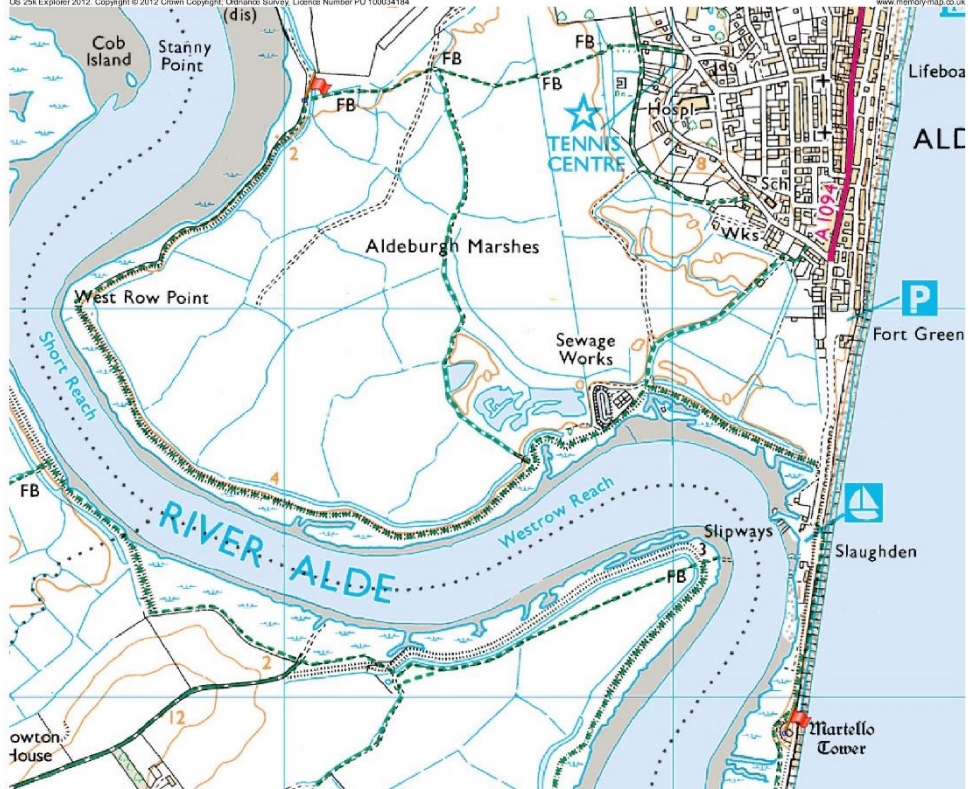
River Wall/Armour	Saltings	High Tide Debris Line
<p>Main weakness at east end of hard front extending from Aldeburgh Sluice where wave action is undermining the bank just where the hard defence ends</p> <p>Puddling at base of south end of new wall steps (not caused by footfall, never improved since wall section was completed.)</p> <p>Path on new stretch all- very bare of grass on walking surface, some strong beta maritima colonies</p> <p>Infestation of alexanders and in one 30 yards stretch winter and winter heliotrope in another</p>	<p>Further erosion of edges- may be not surprising given the very strong winds and hence waves in the river this winter</p> <p>Temporary over-the-wall outfall from drainage ditch onto saltings to be monitored.</p>	<p>Closest debris to top about 2 foot but mostly nearer the base of the walls but lying in very thick swathes where the southerly fetch is strongest (continuous strong S and SW winds over several weeks this winter)- will this damage the growth of saltings vegetation?</p>
