# THE ALDE & ORE ASSOCIATION

## ALDE AND ORE ESTUARY ASSESSORS REPORT

| <b>NAME:</b><br><br><b>Nicholas Russell</b><br><b>Christopher Day</b> | <b>DATE OF INSPECTION:</b><br><br><b>10<sup>th</sup> April 2026</b> |
| <b>FLOOD CELL:</b><br><br>FC1S | <b>AREA OF ASSESSMENT:</b><br><br>Hollesley pumping station to Butley Ferry |

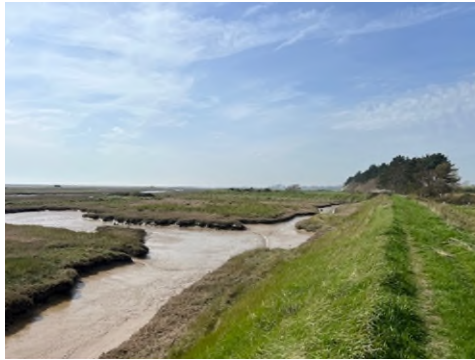
**Pic 12**

- The Simpson Saltings all looked to be in good condition with plenty of healthy marsh between the river and the river wall – See pic 10 and grid refence below.
- The creek that runs behind the 2<sup>nd</sup> WW infantry Pillbox was running well with plenty of healthy marsh between the river and the creek and the creek and the river wall. Sec Pic 11 and 12 below.
- The saltings running along the Butley river and out to the entrance of the Butley river between the river and the wall where in good condition.

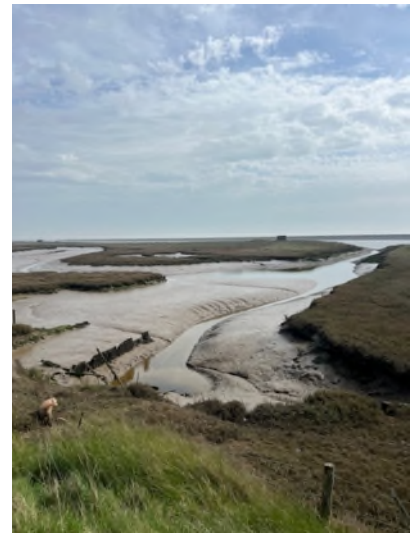
**Pic 13**

- Low. Little evidence other than between Dove Point and the entrance to the Butley where the saltings have completely eroded away and thus the high water is up against the armour . See pic 13 below.
