# THE ALDE & ORE ASSOCIATION

## ALDE AND ORE ESTUARY ASSESSORS REPORT

| <b>NAME:</b><br><br>Roger Baxter<br>Jonathan Evans | <b>DATE OF INSPECTION:</b><br><br>April 2026 |
| <b>FLOOD CELL:</b><br><br>FC2 | <b>AREA OF ASSESSMENT:</b><br><br>Butley Mills |

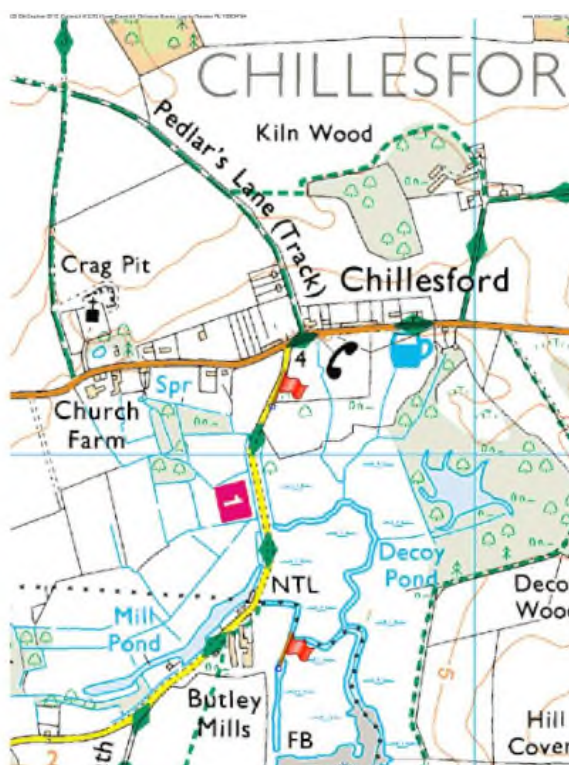
### River Bank surveyed:

Upstream part of River Butley with wide, flat saltings populated by dense reed beds. River Wall is high and wide with a mechanically controllable sluice to allow drainage (under the road) from the mill pond. Grass is thick and short with a footpath on top. The steps from the road to the sluice controls/wall top have recently been replaced.
