# THE ALDE & ORE ASSOCIATION

## ALDE AND ORE ESTUARY ASSESSORS REPORT

| <b>FLOOD CELL:</b><br><br>FC4.3 | <b>AREA OF ASSESSMENT:</b><br><br>Pump House to Orford Town<br>TM 454536- TM427497<br><br>Walked Orford to Pump House, hence<br>comments in that order. |

## River Bank surveyed: Orford Town to Pump House TM427497 to TM454536

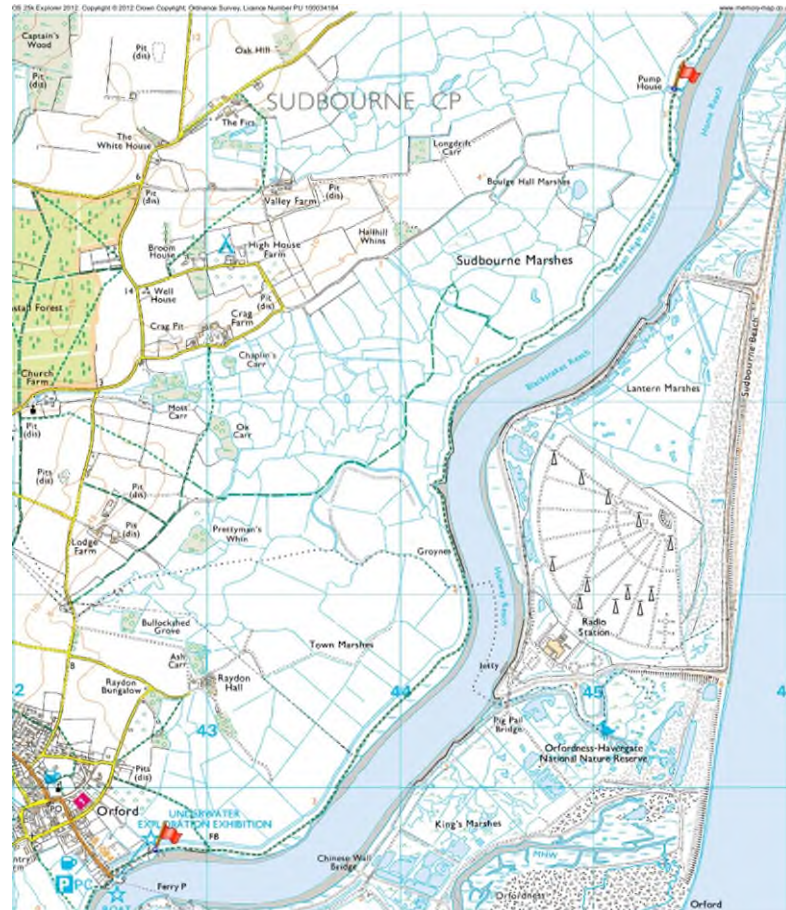
**Footpath:** Very heavily worn from Orford Sailing Club for first 300 metres, then the next 3.5 km crest in good/very good condition, last 600m up to Pump House, very narrow overgrown top.

**Embankment crest and slopes:** mostly good condition, grassy and gentle slope except for first 600 metres from Orford are steep and overgrown with Alexanders, and the last 600 metres before Pump House where slope is steep sided on landward side and over 100 metres actually overgrown with reeds.

**Front/river face:** mostly good condition, in a few places slight isolated disruption of concrete blocks.
