## ALDE AND ORE ESTUARY ASSESSORS REPORT

| <b>NAME:</b><br><br>Frances Barnwell | <b>DATE OF INSPECTION:</b><br><br>29 April 2026 |
| <b>FLOOD CELL:</b><br><br>FC4-1 | <b>AREA OF ASSESSMENT:</b><br><br>Gedgrave & Sudbourne Marshes |

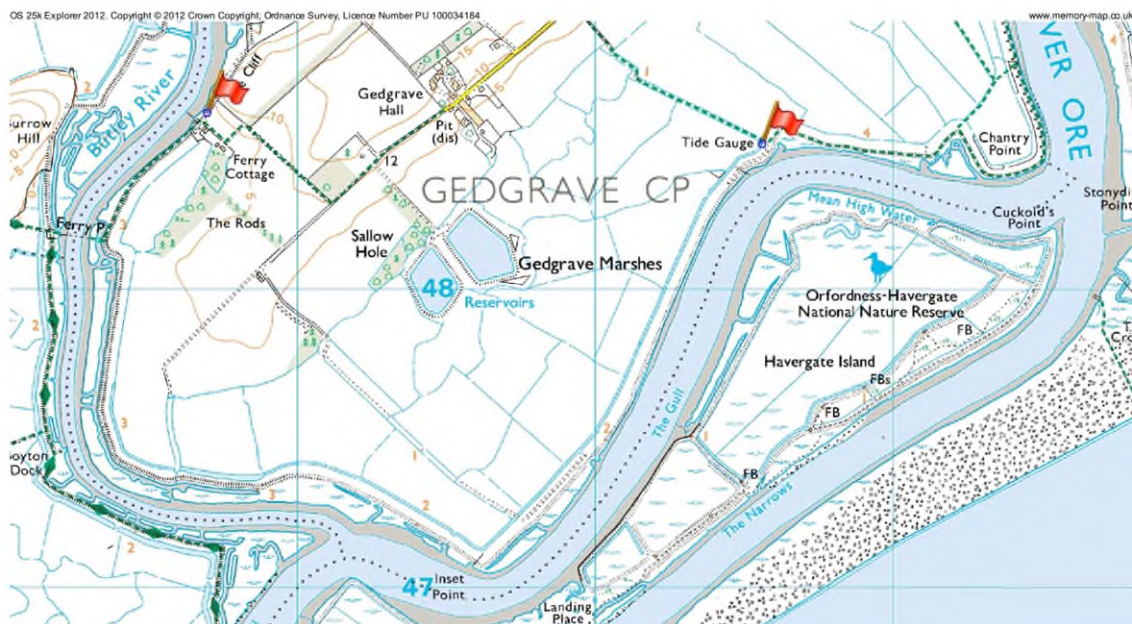
### River Bank surveyed:

This section of the walls appears in reasonable condition but it was notable that cattle have been congregating on the tops of the wall in places with associated and visible damage to the surface and sides.

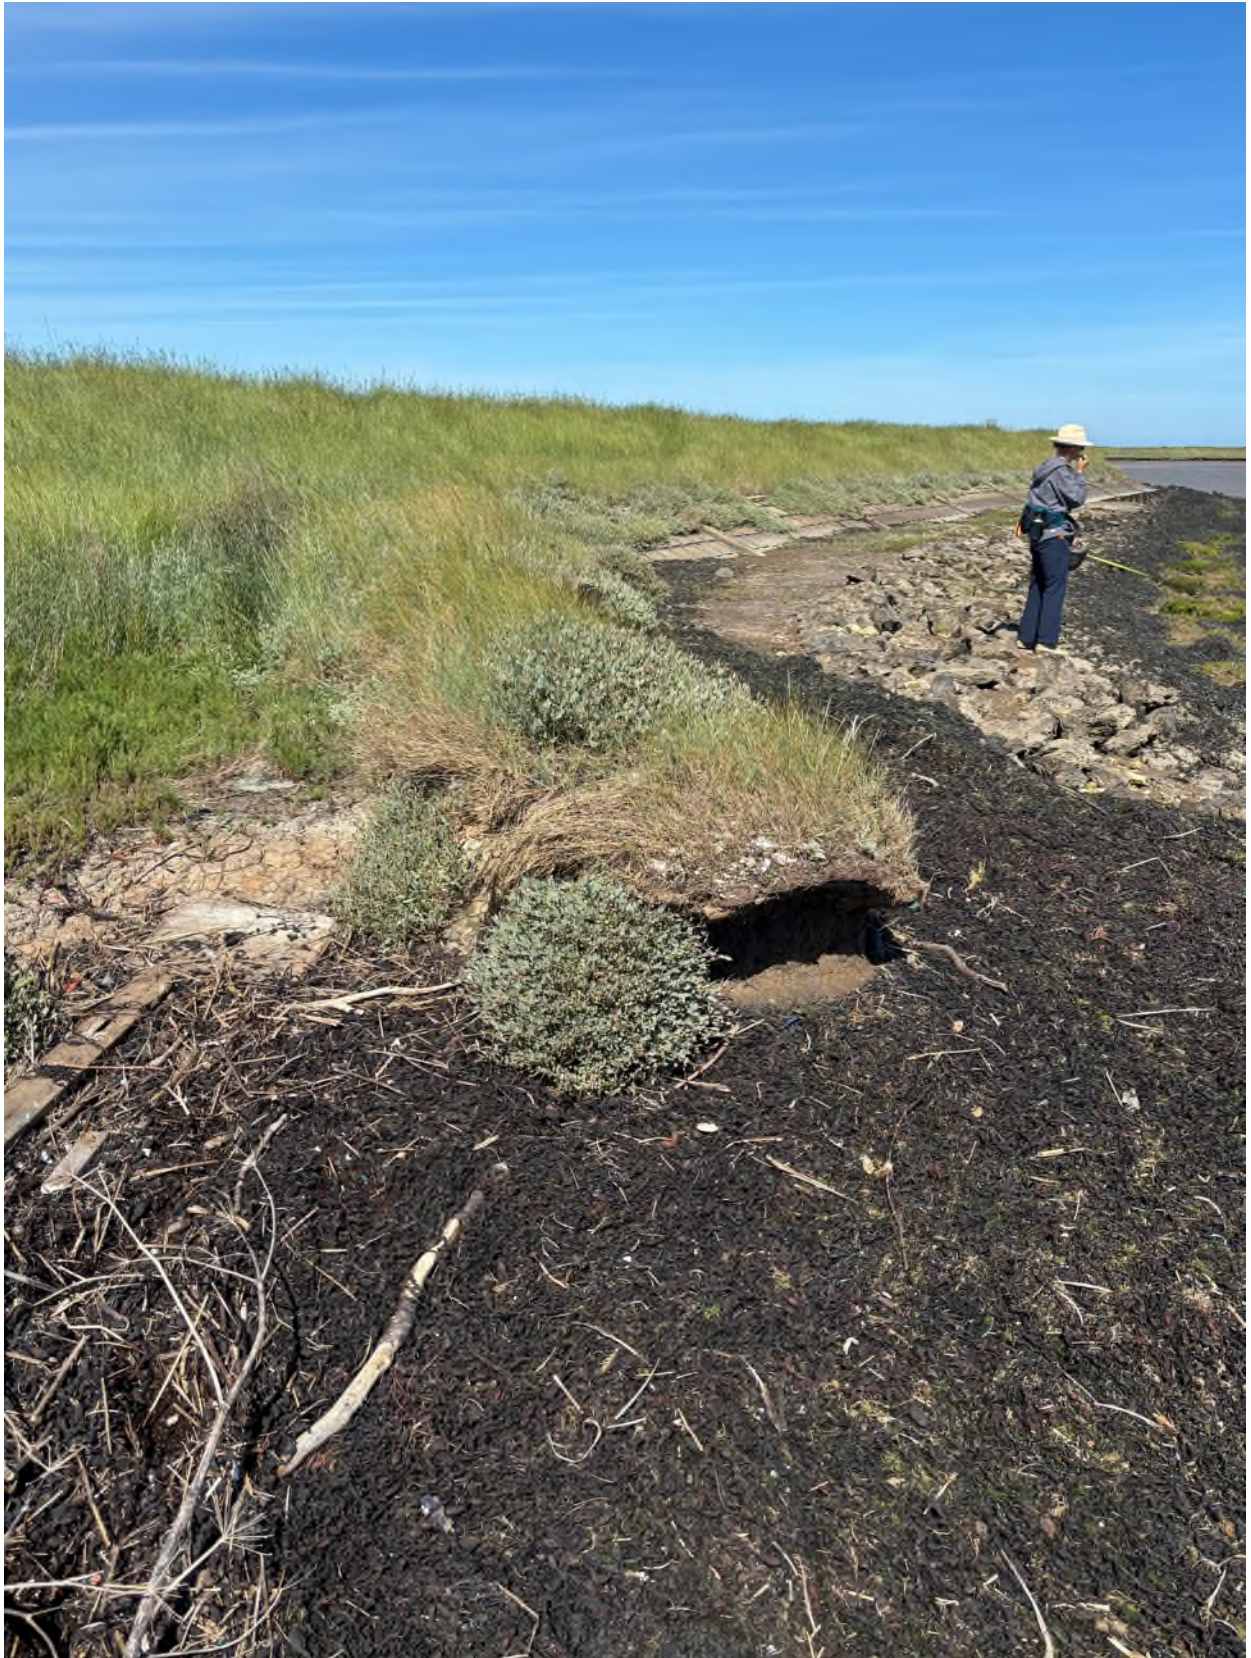
The boundary area joining FC4.1 and .2 appears relatively low but Lidar data would be needed to give a more accurate assessment'

At this point there is a 'peninsula' of earth extending between two sections of blockwork. This is clearly deteriorating.

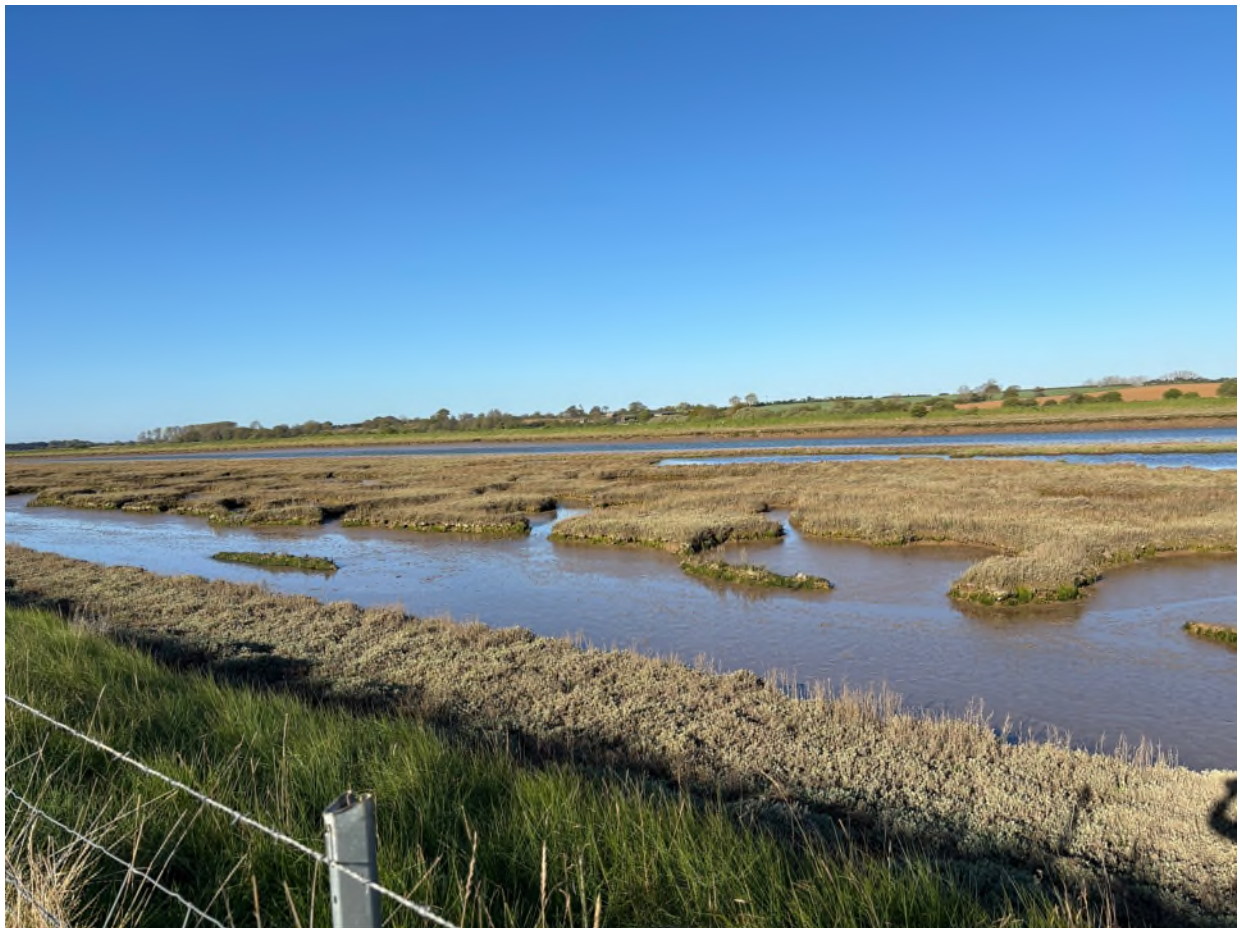
The channels in saltings between the Butley mouth and Pinneys continue to show a widening of the mud channels at the expense of the vegetation.

Overall, I would judge this section as a 3.
